## **ADDENDUM No. 1**

**Project Name:**            **Government Tower - Roof**  
                                  **8026 Main Street, Houma LA 70360**  
                                  **Terrebonne Parish Consolidated Government**

# Roof Moisture Survey

## Government Towers

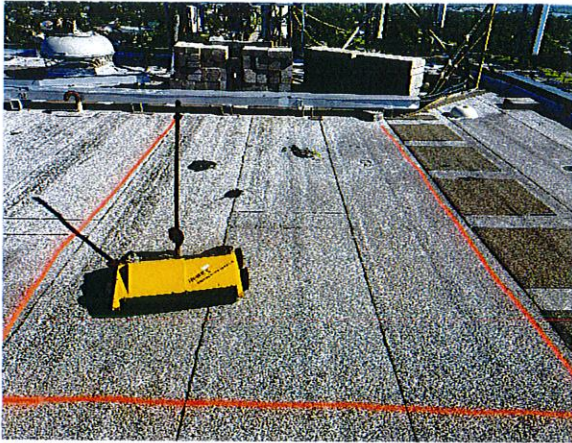
The existing roof system is a 2-ply modified bitumen membrane over ½” gypsum cover board over 1 ½” polyisocyanurate insulation over lightweight insulating concrete over metal decking. There was a large puncture observed in the roofing membrane and positive moisture readings were observed in this area. There were some missing and damaged metal copings and damaged cap sheet membrane observed.

Penthouse Roof – moisture detected

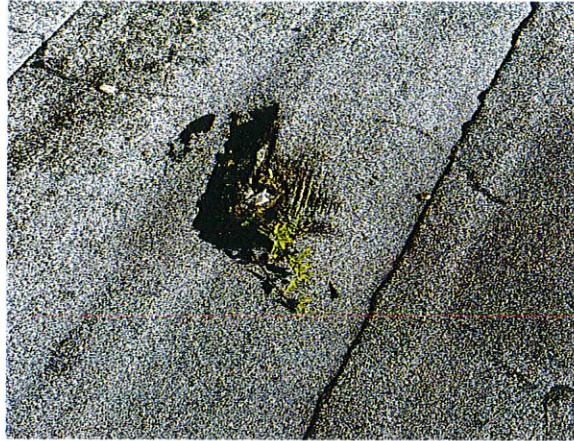
Penthouse Roof – large puncture

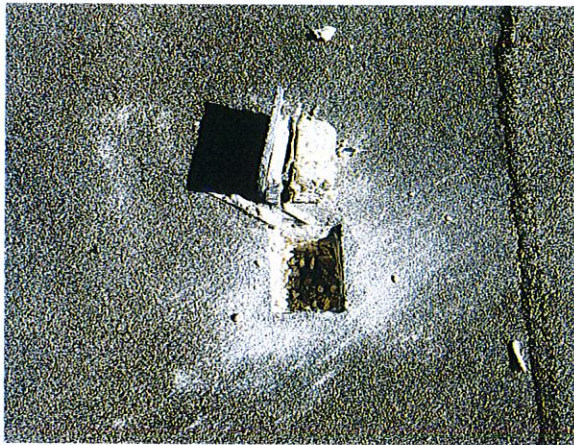
- Test Cut # 1: Dry
- Test Cut # 2: Dry

Penthouse Roof – Test Cut # 1

The description of the findings is shown on the attached roof sketch. All test cuts were repaired using a 3 coursing of asphaltic roofing cement and fiberglass fabric.

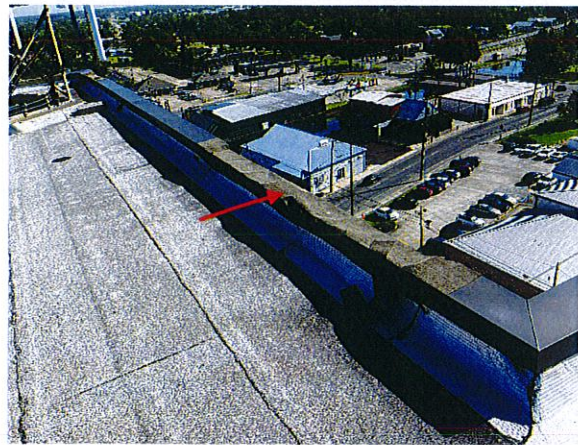
Penthouse Roof – missing metal coping

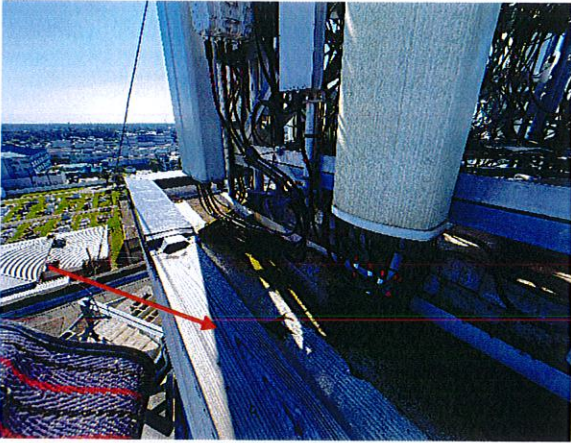
There was no moisture survey performed on this roof section. The existing roof system is completely cover with communications equipment. Missing and damaged metal coping observed.

Tower Roof – missing metal coping

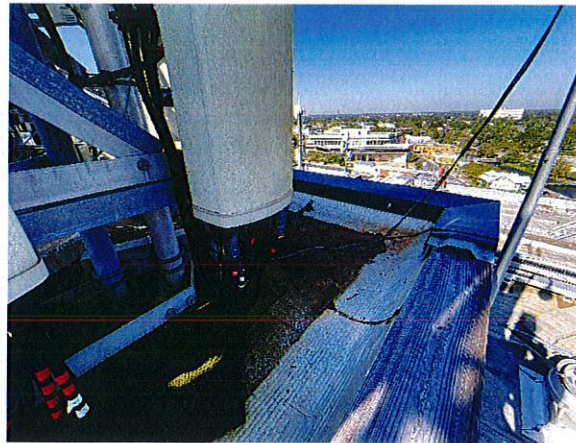
Tower Roof – communications equipment

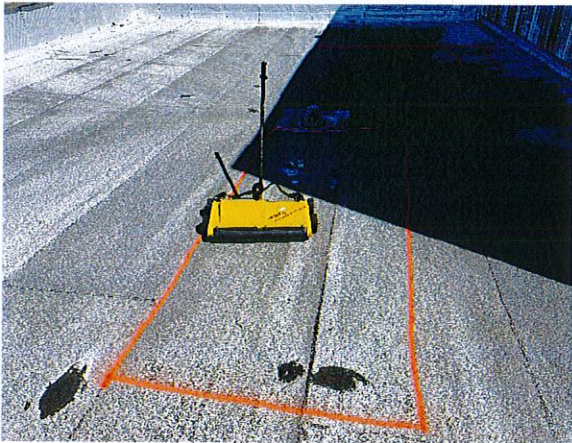
The existing roof system is a 2-ply modified bitumen membrane over ½" gypsum cover board over 1 ½" polyisocyanurate insulation over structural concrete. Positive moisture readings were detected at multiple locations. There were roof punctures and missing metal copings observed.

7<sup>th</sup> Floor Roof – moisture detected

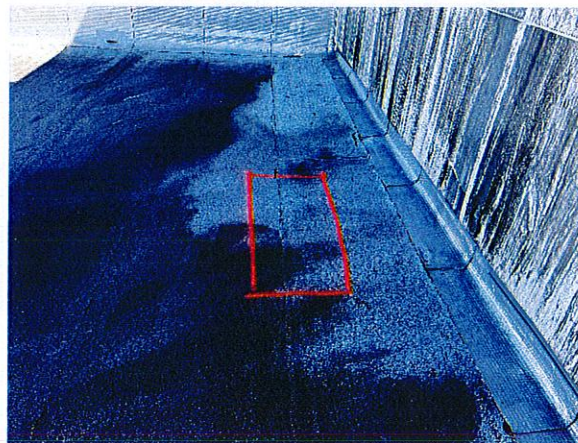
7<sup>th</sup> Floor Roof – moisture detected

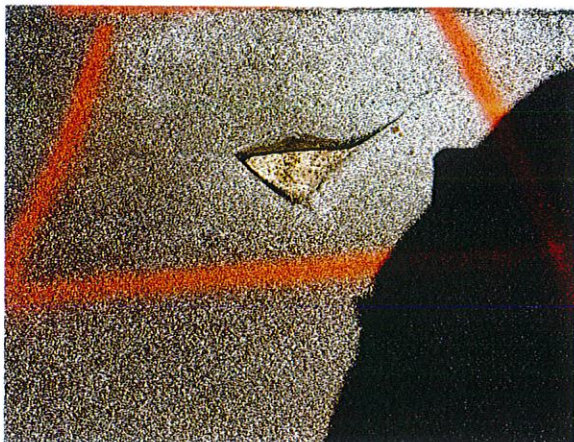
7<sup>th</sup> Floor Roof – roof puncture

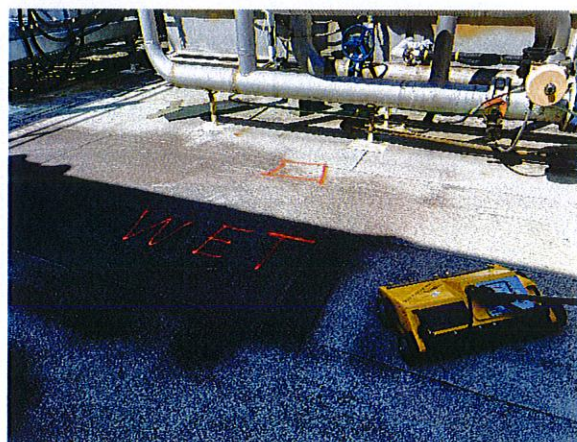
7<sup>th</sup> Floor Roof – moisture detected

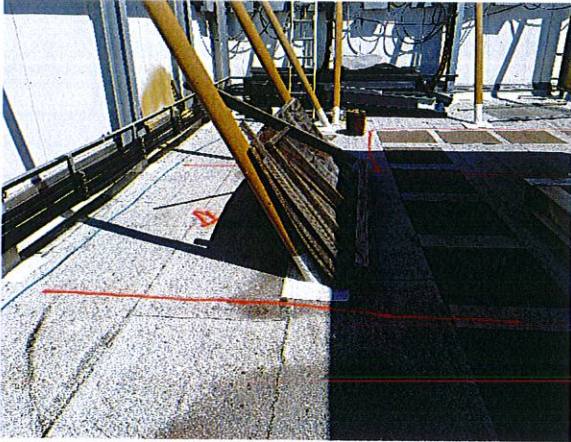
7<sup>th</sup> Floor Roof – moisture detected

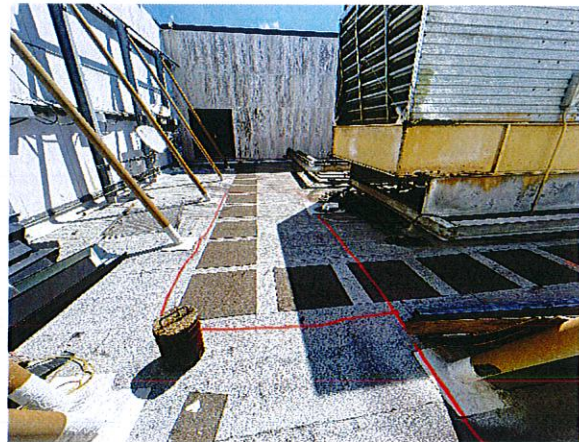
7<sup>th</sup> Floor Roof – moisture detected

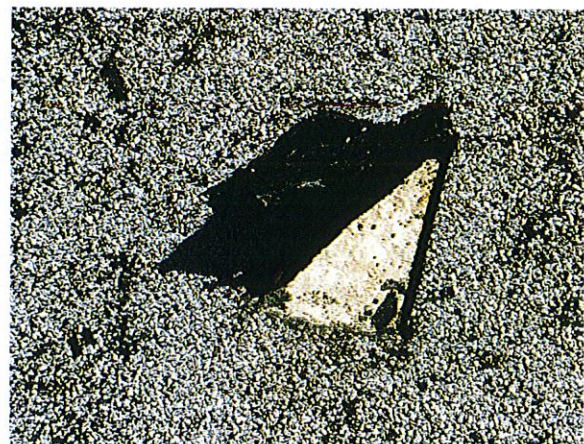
- Test Cut # 1: Dry

Council Chamber Roof – Test Cut # 1

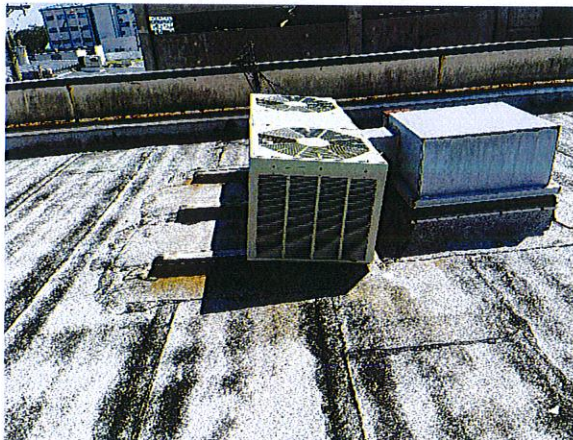
Council Chamber Roof – mechanical equipment laying on roof

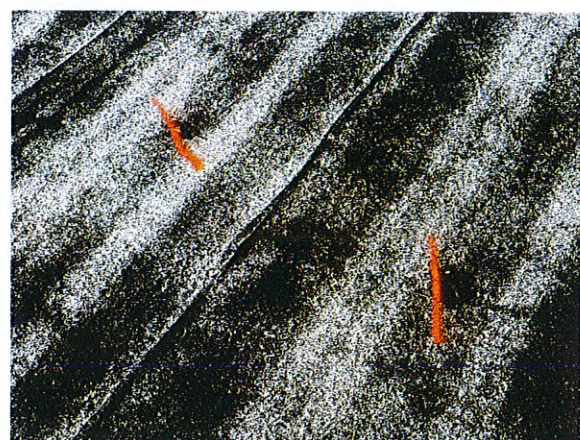
Council Chamber Roof – temp repairs

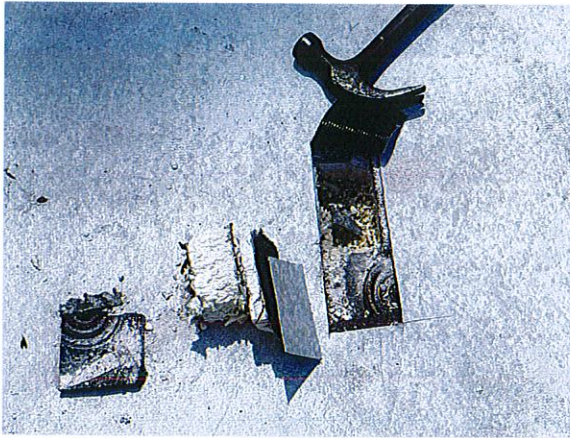
- Test Cut # 1: Dry
- Test Cut # 2: Wet – (gypsum cover board was wet to the touch)

Bank Lobby Roof – Test Cut # 1

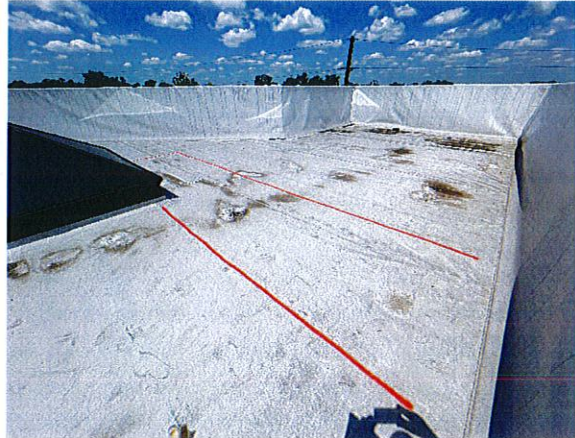
The existing roof has a temporary single-ply membrane over a 2-ply modified bitumen membrane over ½" gypsum cover board over 1 ½" polyisocyanurate insulation over lightweight insulating concrete over a metal deck. Positive moisture readings were detected at multiple locations.

Bank Lobby Roof – moisture detected

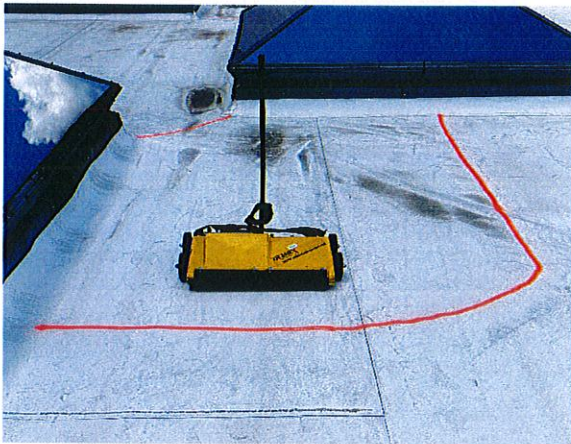
Bank Lobby Roof – moisture detected

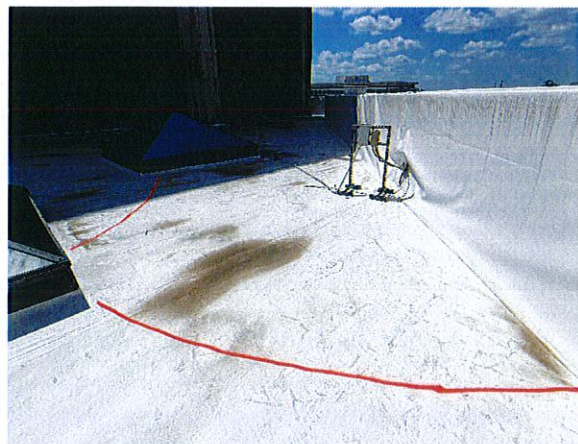
Bank Lobby Roof – moisture detected

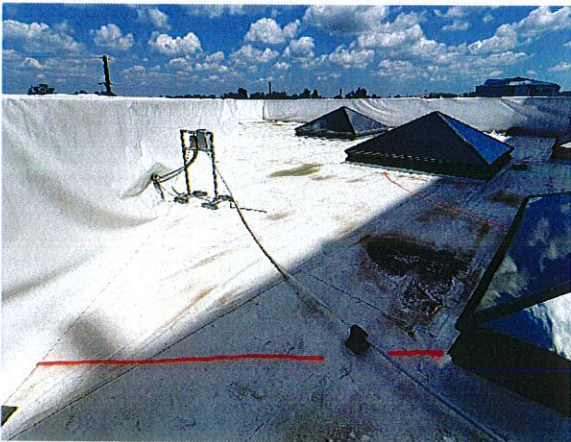
Bank Lobby Roof – moisture detected

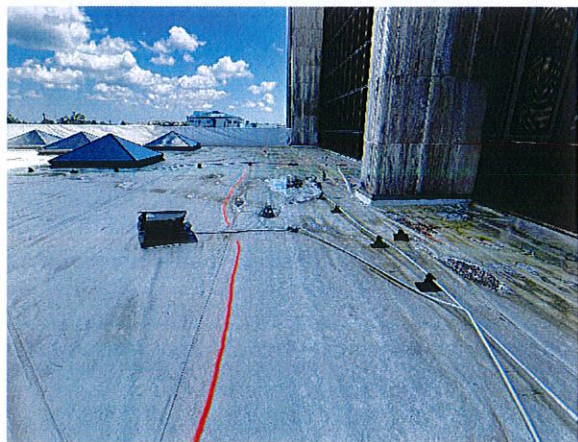
Bank Lobby Roof – moisture detected

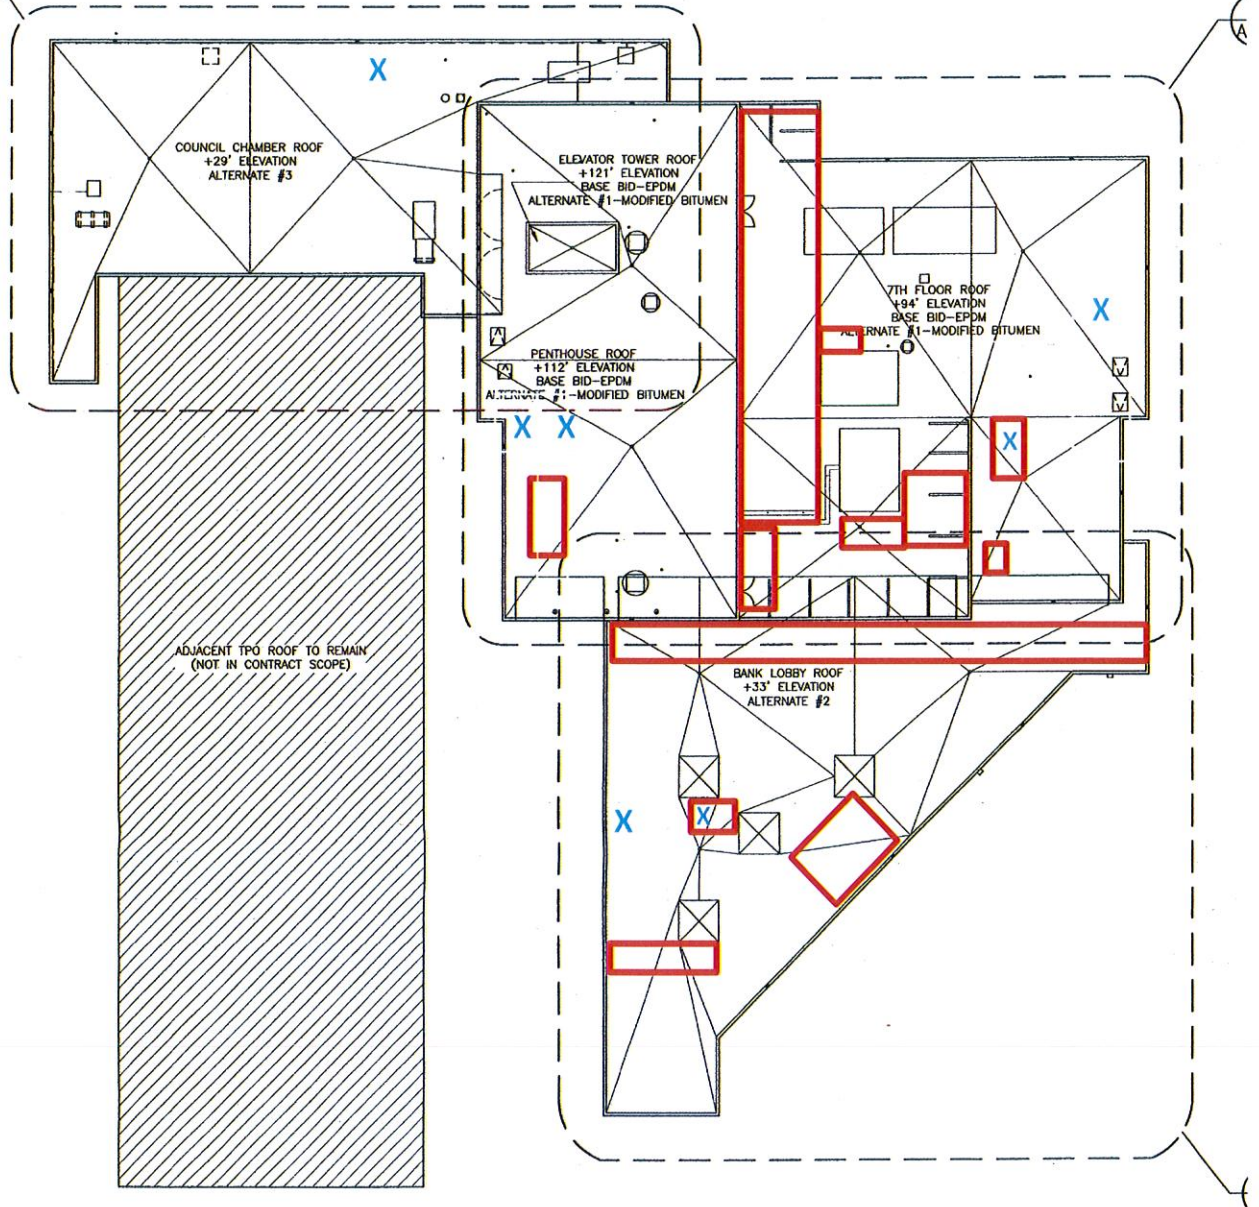
1 **OVERALL ROOF PLAN**  
1/16" = 1'-0"

Positive moisture readings were detected and located on the roof using marking paint. See attached roof plan with approximate locations.

**Red Boxes** – Moisture detected in these areas.

**X** – Test Cut Locations
