TERREBONNE PARISH CONSOLIDATED GOVERNMENT

HURRICANE IDA DAMAGE REPAIRS

MAYFIELD BRIDGES #1 & #2

ADDENDUM NO. 2

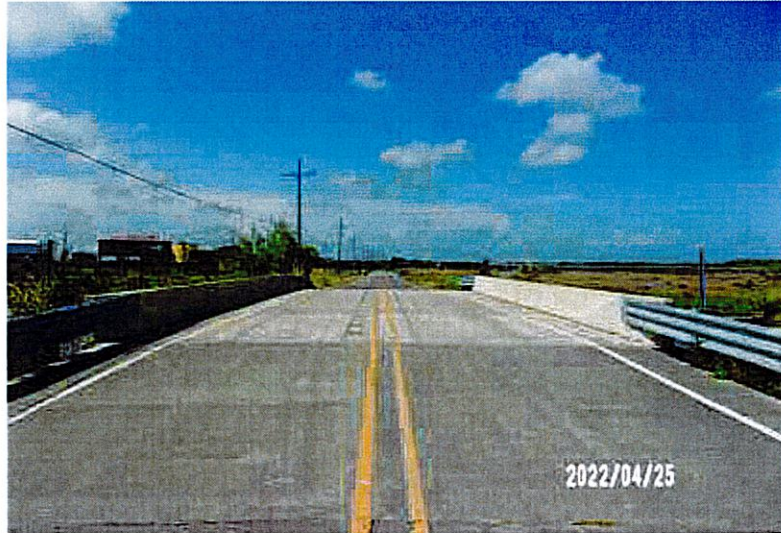
PHOTO 1

DESCRIPTION: Direction of inventory, south end of bridge.

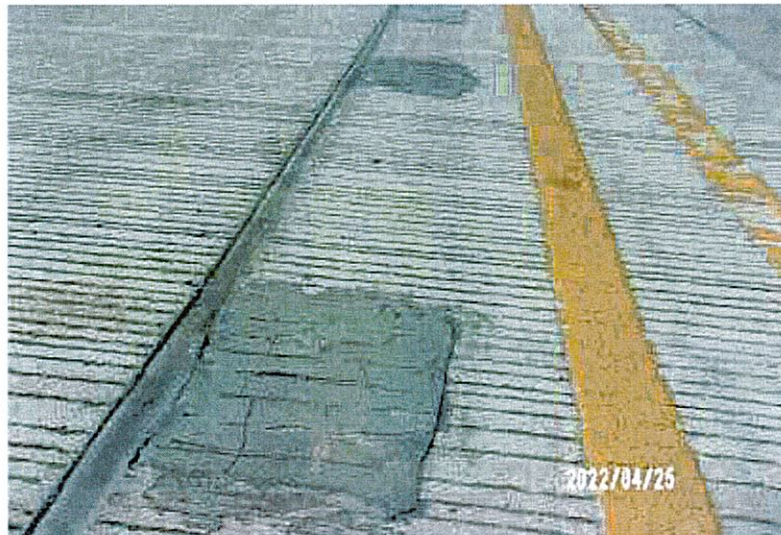
PHOTO 2

DESCRIPTION: Span 1, panel 4, patched area. Typical of span.

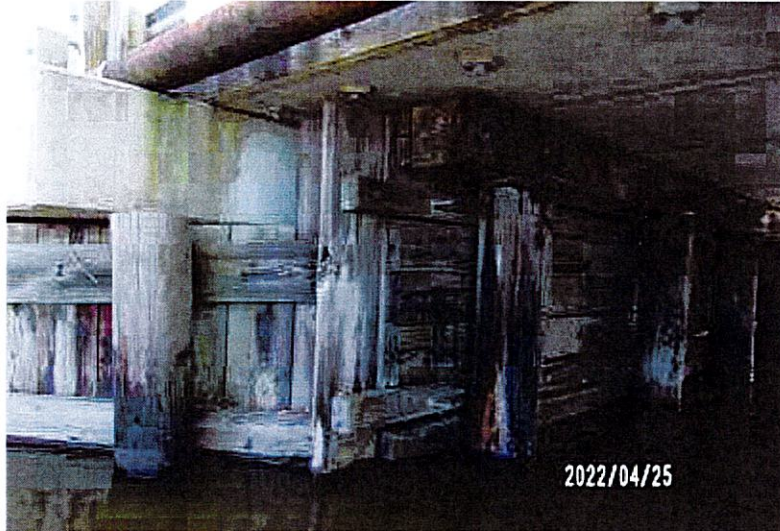
PHOTO 3

DESCRIPTION: Timber retaining wall from previous structure.

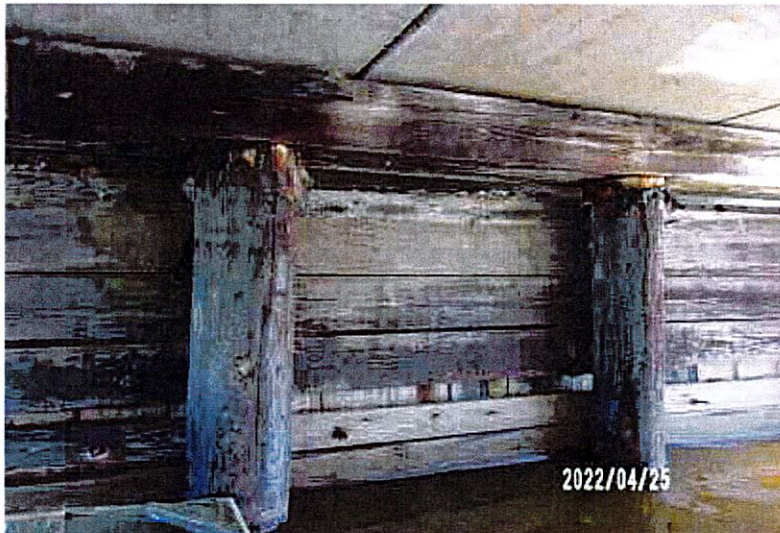
PHOTO 4

DESCRIPTION: Timber retaining wall from previous structure.

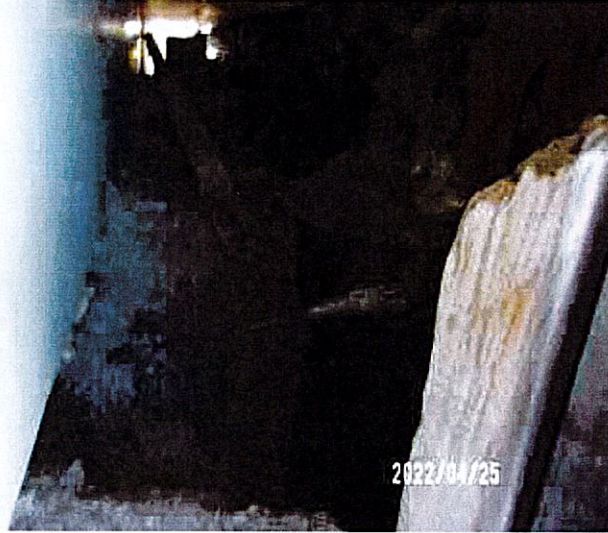
PHOTO 5

216 - Timber Abutment						
<u>TOTAL QUANTITY</u>	<u>UNITS</u>	<u>CONDITION STATE 1</u>	<u>CONDITION STATE 2</u>	<u>CONDITION STATE 3</u>	<u>CONDITION STATE 4</u>	
62	Ft.	60	2	0	0	
	<u>DEFECTS</u>		<u>QTY CS 2</u>	<u>QTY CS 3</u>	<u>QTY CS 4</u>	
	1140 - Decay/Section Loss		2	0	0	
<p>NOTES:</p> <ol style="list-style-type: none"> 1. Timber retaining walls, 31' long each. 2. The abutments from the previous structure were retained and are serving as bulkheads for the current structure (photos 3 - 4). The retaining walls are in generally good condition, with some minor deterioration in a few areas [CS2]. 3. The fill material on the inside of both walls is washing out along the entire length of the walls (photos 5 - 6).

DESCRIPTION: Washout behind retaining wall.

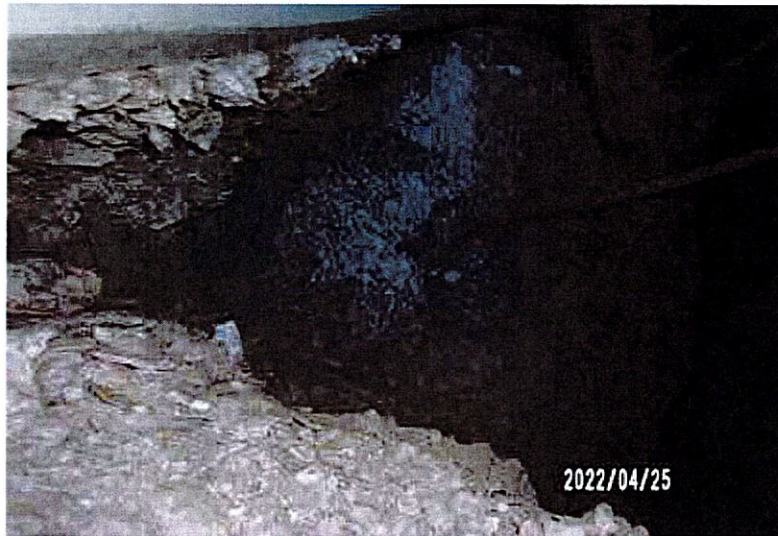
PHOTO 6

DESCRIPTION: Washout behind retaining wall.

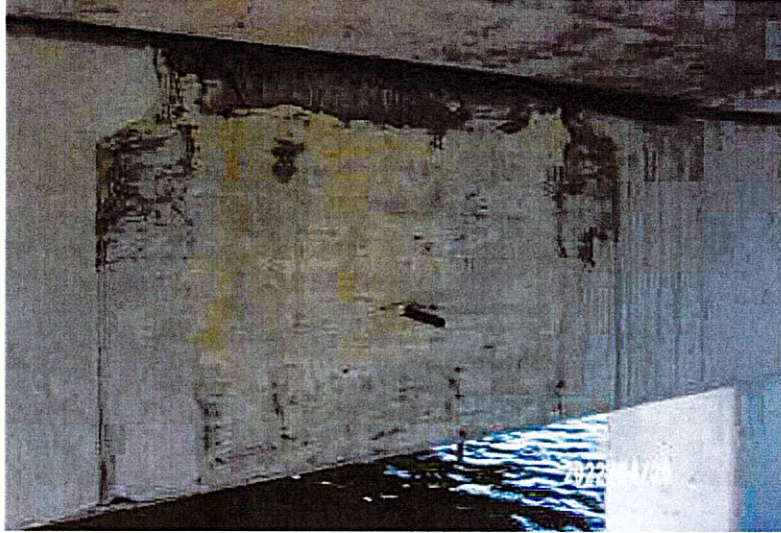
PHOTO 7

DESCRIPTION: Cap 2, patched area. Typical of caps.

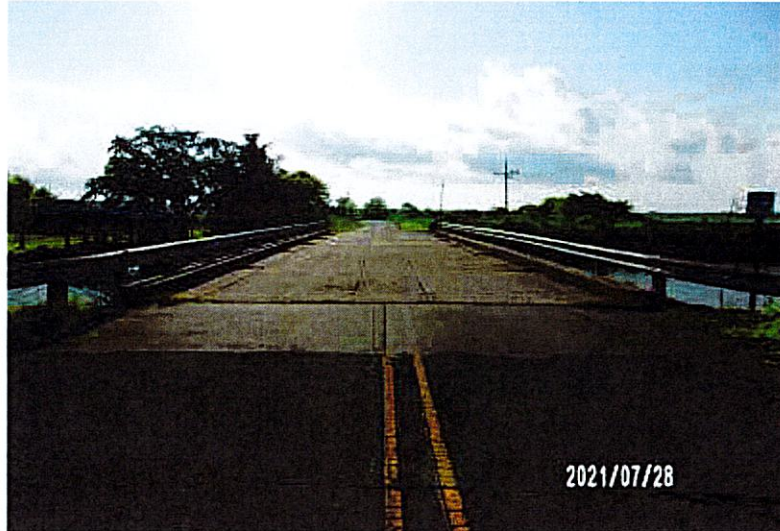
PHOTO 1

DESCRIPTION: Direction of inventory, west end of bridge.

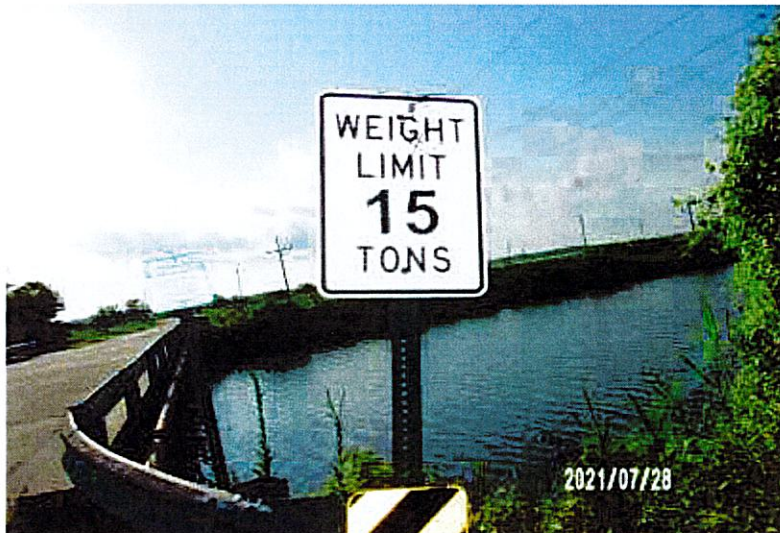
PHOTO 2

DESCRIPTION: Nearside weight limit sign.

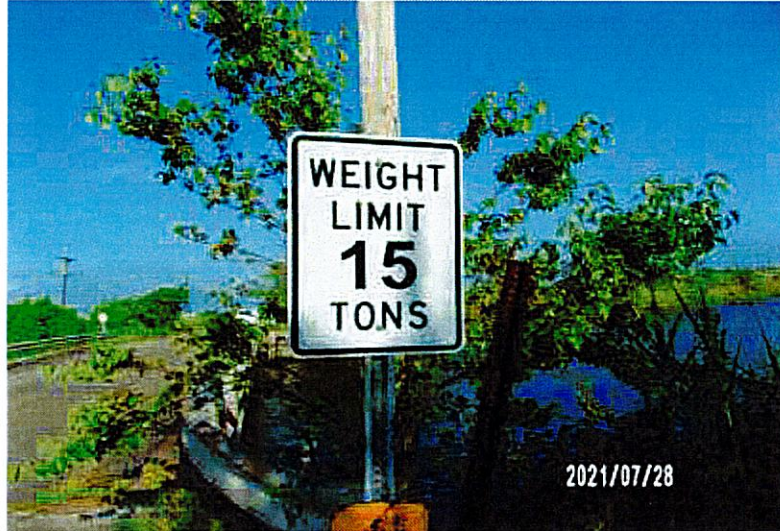
PHOTO 3

DESCRIPTION: Farside weight limit sign.

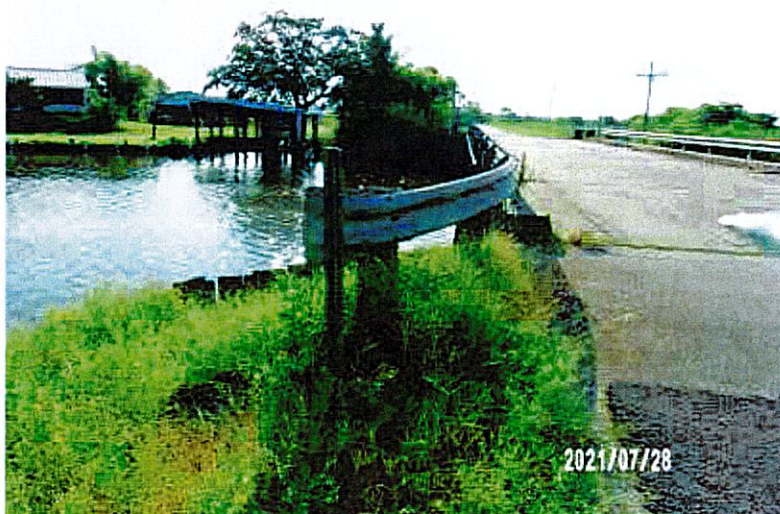
PHOTO 4

DESCRIPTION: Nearside left hazard marker missing.

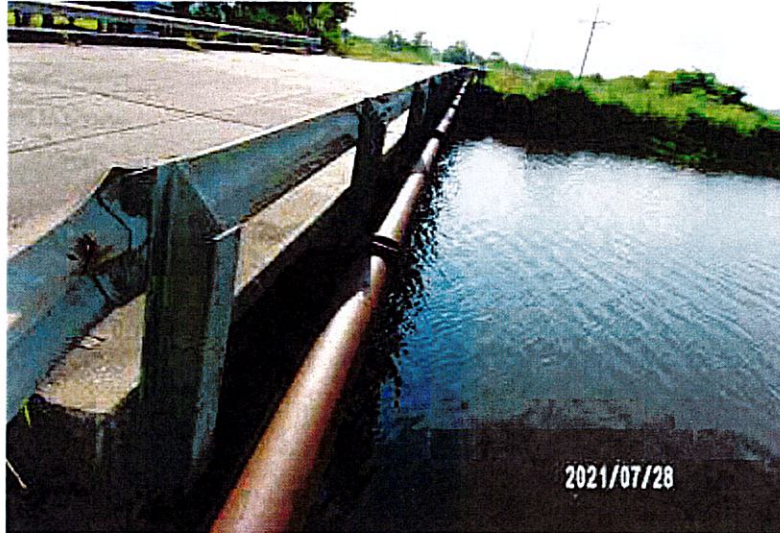
PHOTO 5

DESCRIPTION: Water main along right side of span.

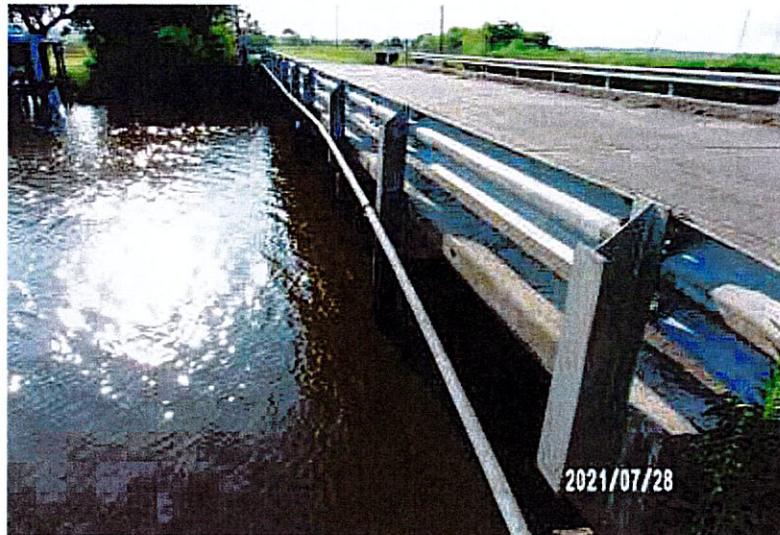
PHOTO 6

DESCRIPTION: Communications line along left side of span.

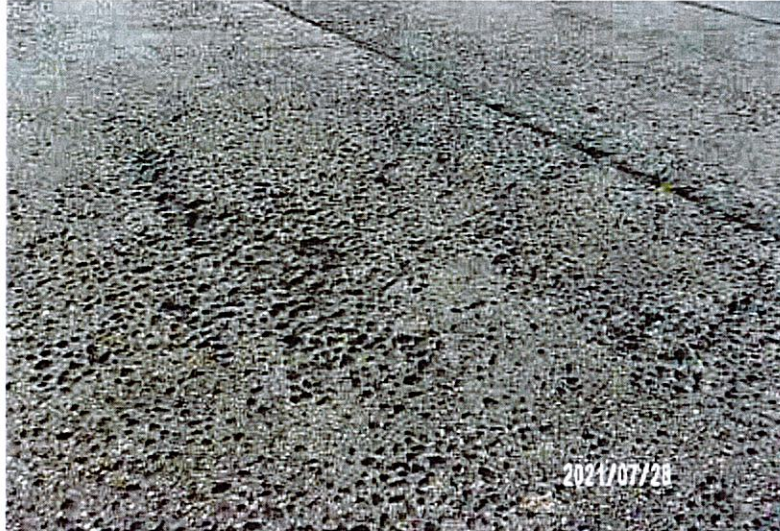
PHOTO 7

DESCRIPTION: Deck surface wear.

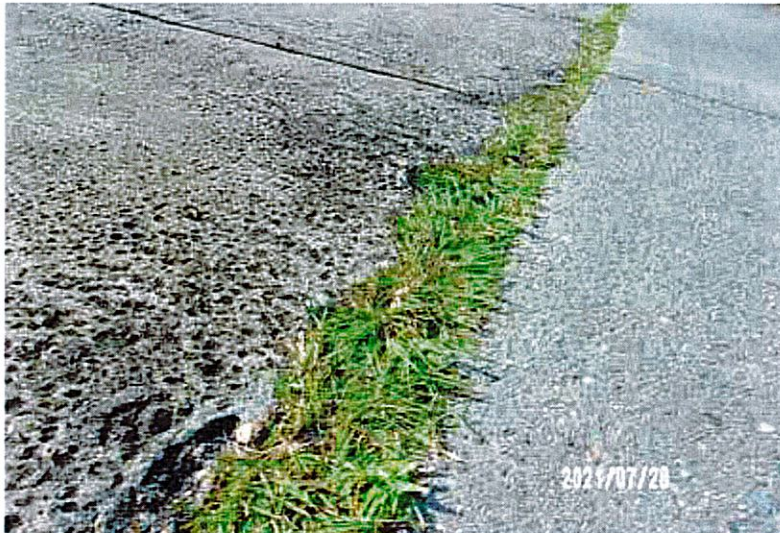
PHOTO 8

DESCRIPTION: Span 1, panel 2 - 5, spalling along joint 1.

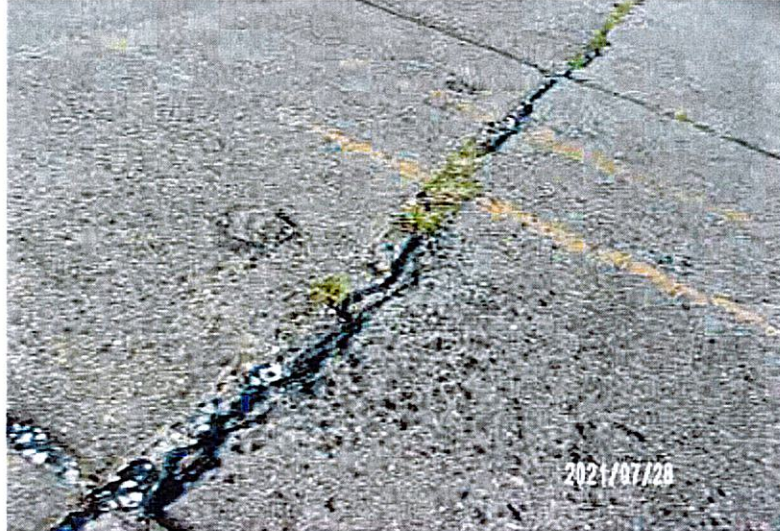
PHOTO 9

DESCRIPTION: Span 6, panel 4, spall along joint 5.

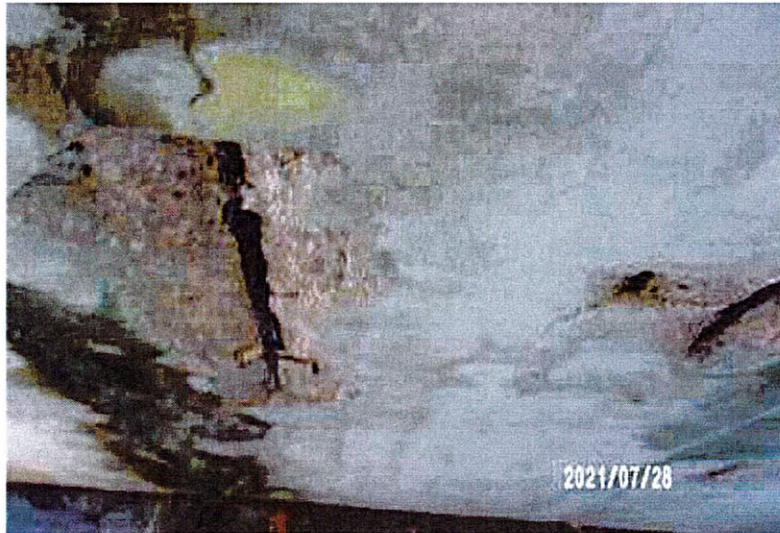
PHOTO 10

21. Span 1, panel 1 underside has a spalled/delaminated area, 7" x 8" with exposed rebar [CS3].
22. Span 1, panel 2 underside has a spalled/delaminated area, 14" x 48" with exposed rebar [CS4] (photos 10 -11).

DESCRIPTION: Span 1, panel 2 underside, spalling/delamination with exposed corroded rebar.

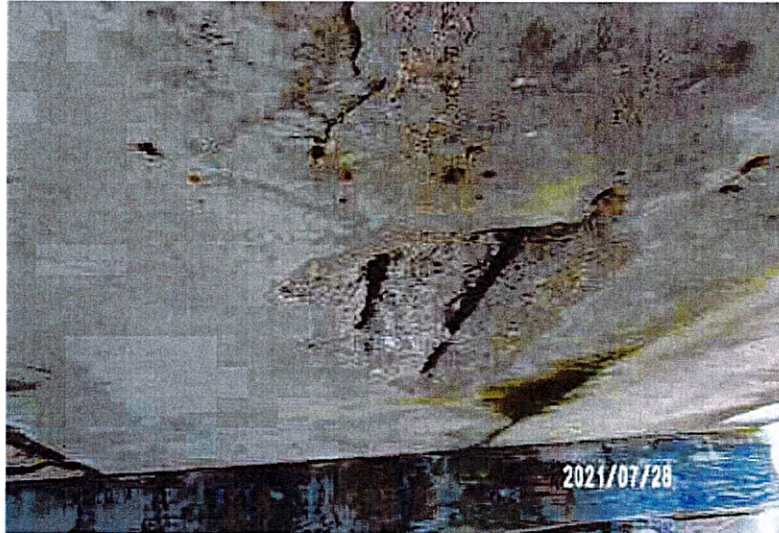
PHOTO 11

DESCRIPTION: Span 1, panel 2 underside, spalling/delamination with exposed corroded rebar.

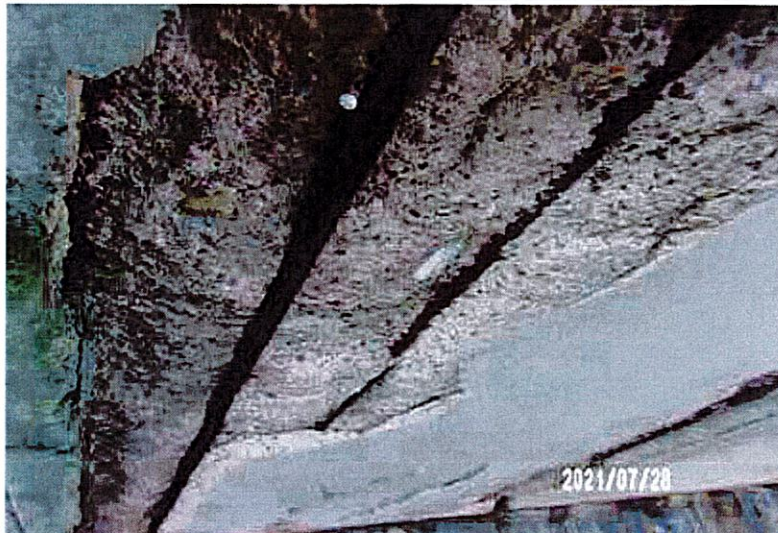
PHOTO 12

23. Span 1, panel 3 underside has a spalled/delaminated area, 48" x 48" with exposed rebar [CS4] (photos 12 -14).
24. Span 1, panel 3 underside has delaminated area, 16" x 10", ~ 5' away from cap 2 [CS2].

DESCRIPTION: Span 1, panel 3 underside, spalling/delamination with exposed corroded rebar.

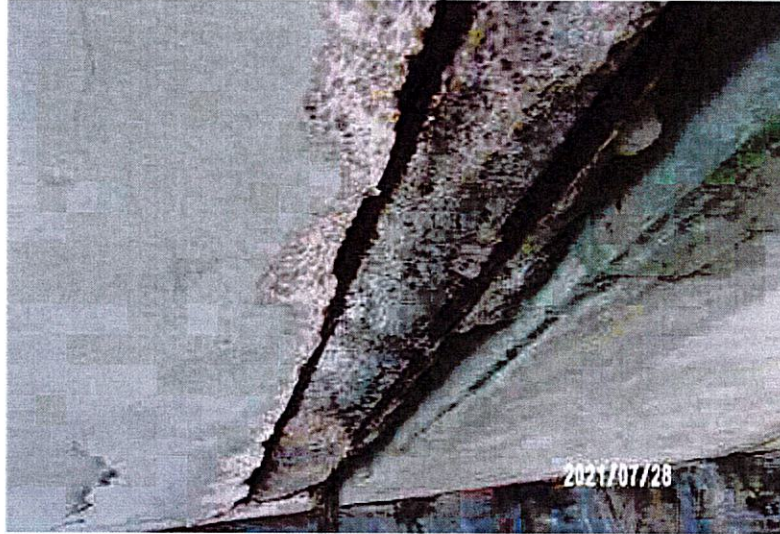
PHOTO 13

DESCRIPTION: Span 1, panel 3 underside, spalling/delamination with exposed corroded rebar.

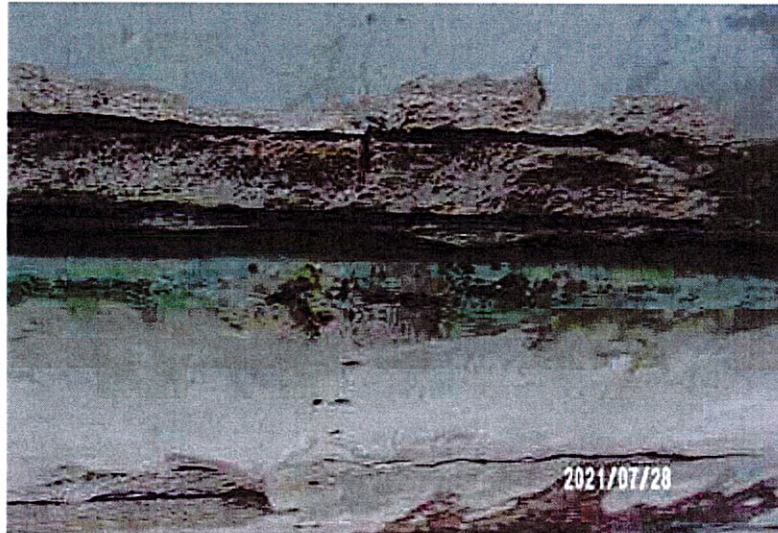
PHOTO 14

DESCRIPTION: Span 1, panels 2- 3 underside, spalling/delamination with exposed corroded rebar.

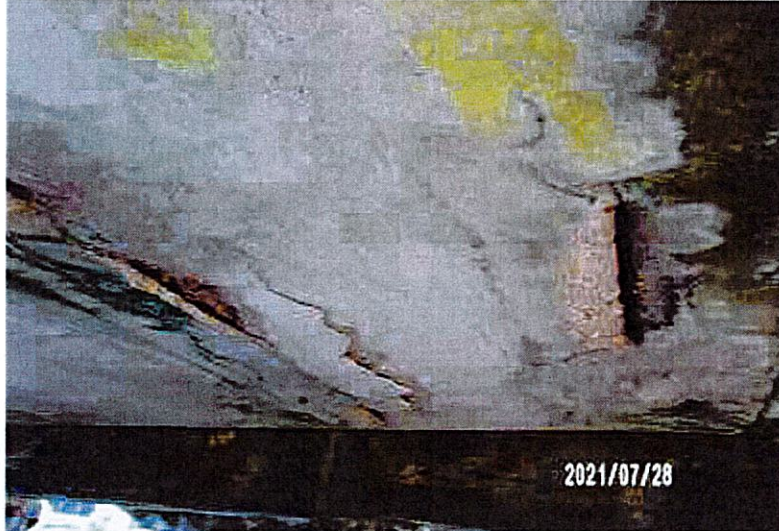
PHOTO 15

29. Span 1, panel 6 underside has a spalled/delaminated area, 228" x 25" with exposed rebar, along the left edge [CS3] (photos 15 - 16).
30. Span 1, panel 6 underside has a spalled/delaminated area, 60" x 26" with exposed rebar [CS3].

DESCRIPTION: Span 1, panel 6 underside, spalling/delamination with exposed corroded rebar.

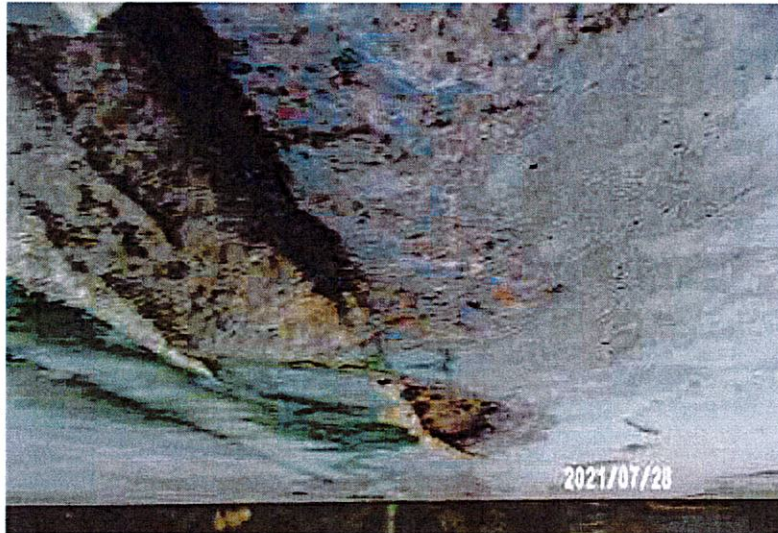
PHOTO 16

DESCRIPTION: Span 1, panel 6 underside, spalling/delamination with exposed corroded rebar.

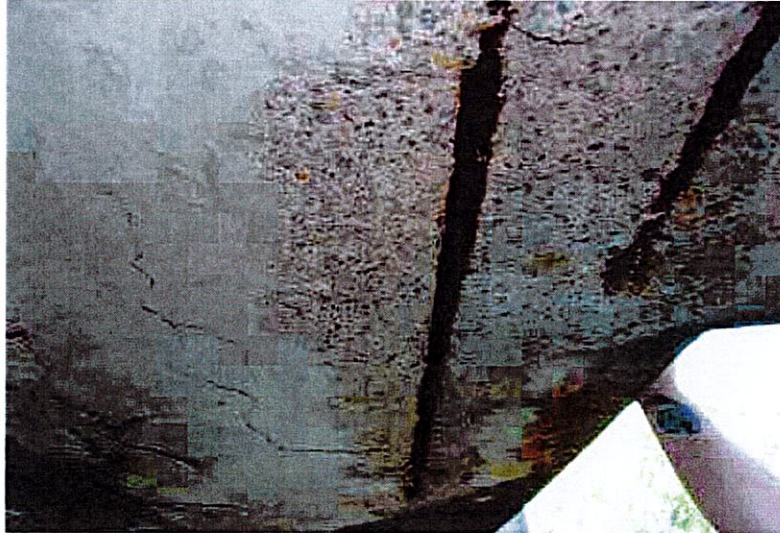
PHOTO 17

33. Span 2, panel 1 underside has a spalled/delaminated area, 32" x 12" with exposed rebar [CS4] (photo 17).

DESCRIPTION: Span 2, panel 1 underside, spalling/delamination with exposed corroded rebar.

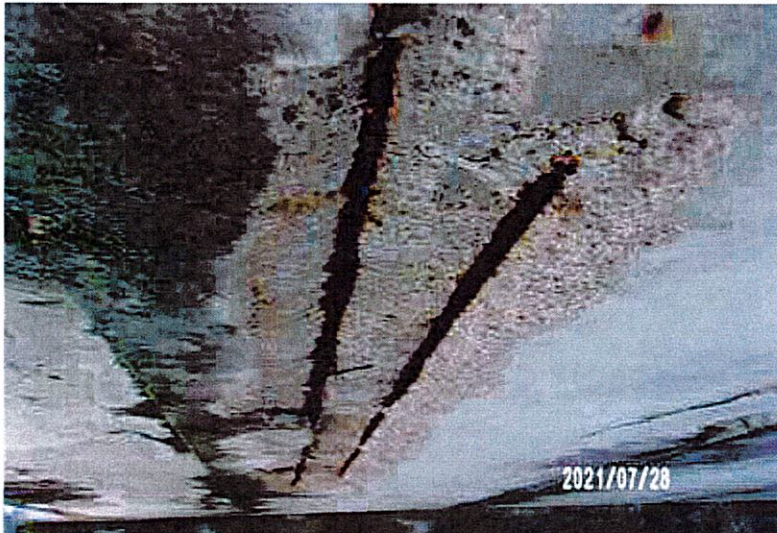
PHOTO 18

34. Span 2, panel 1 underside is spalled, 12" x 10" with exposed rebar [CS3].
35. Span 2, panel 2 underside has a spalled/delaminated area, 120" x 22" with exposed rebar [CS4] (photo 18).

DESCRIPTION: Span 2, panel 2 underside, spalling/delamination with exposed corroded rebar.

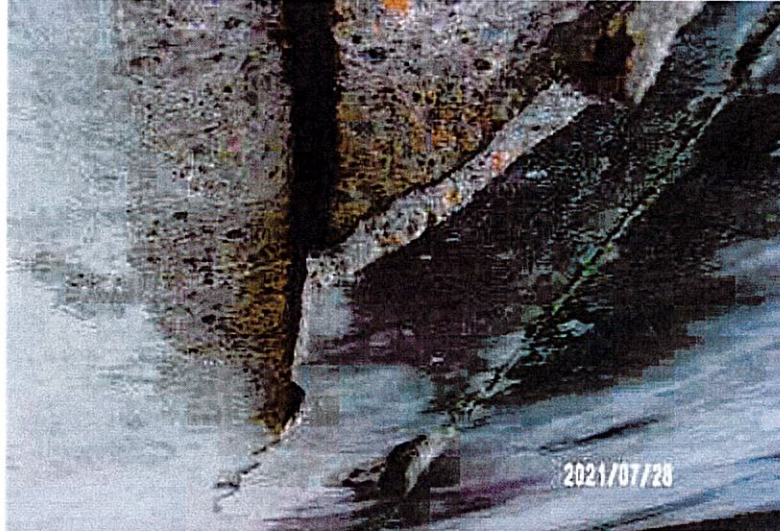
PHOTO 19

36. Span 2, panel 2 underside has a spalled/delaminated area, 84" x 15" with exposed rebar [CS4] (photo 19).
37. Span 2, panel 3 underside has a delaminated area, 35" x 15" [CS2].

DESCRIPTION: Span 2, panel 2 underside, spalling/delamination with exposed corroded rebar.

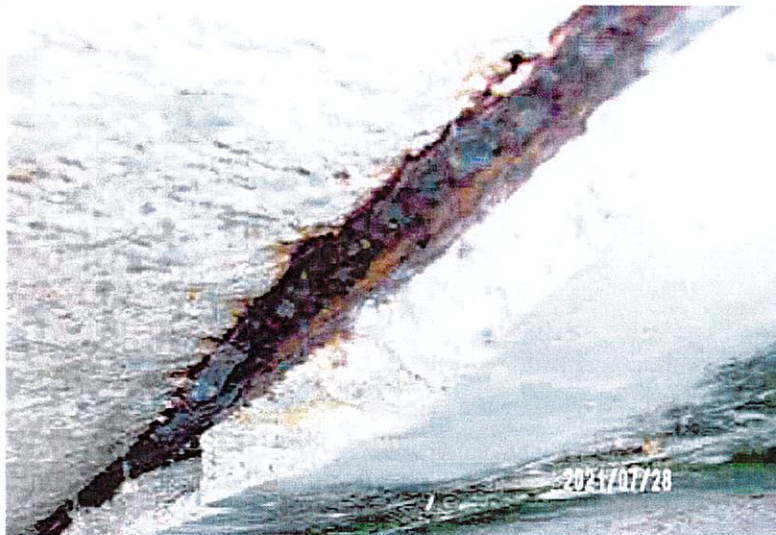
PHOTO 20

40. Span 2, panel 4 underside has a spalled/delaminated area, 120" x 15" with exposed rebar [CS4] (photo 20).
41. Span 2, panel 4 underside has a spalled/delaminated area, 74" x 16" with exposed rebar [CS3] (photo 21).

DESCRIPTION: Span 2, panel 4 underside, spalling/delamination with exposed corroded rebar.

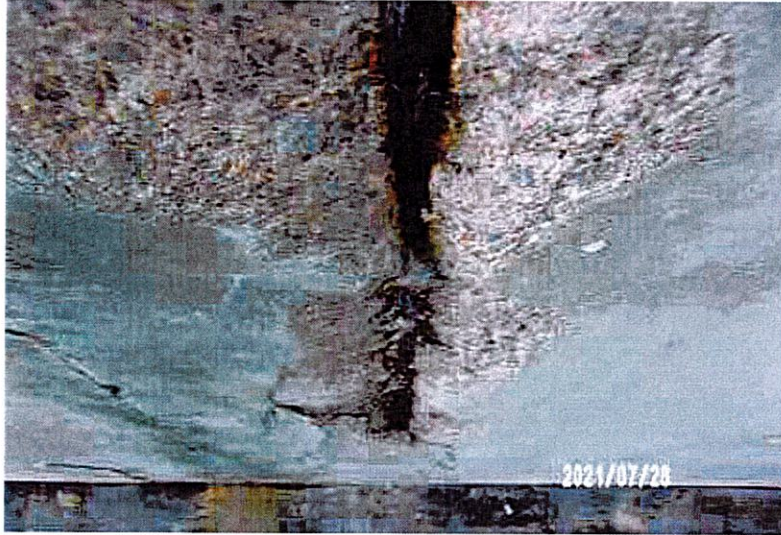
PHOTO 21

DESCRIPTION: Span 2, panel 4 underside, spalling/delamination with exposed corroded rebar.

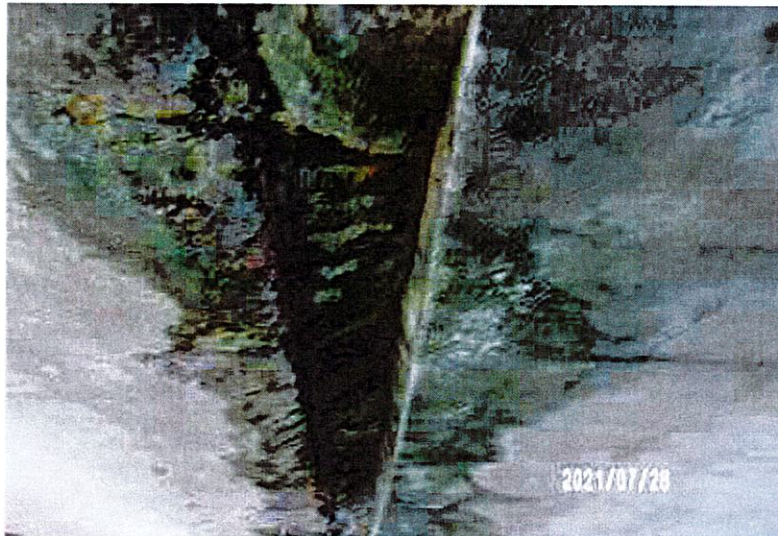
PHOTO 22

DESCRIPTION: Span 2, panel 6 underside, spall with exposed corroded rebar.

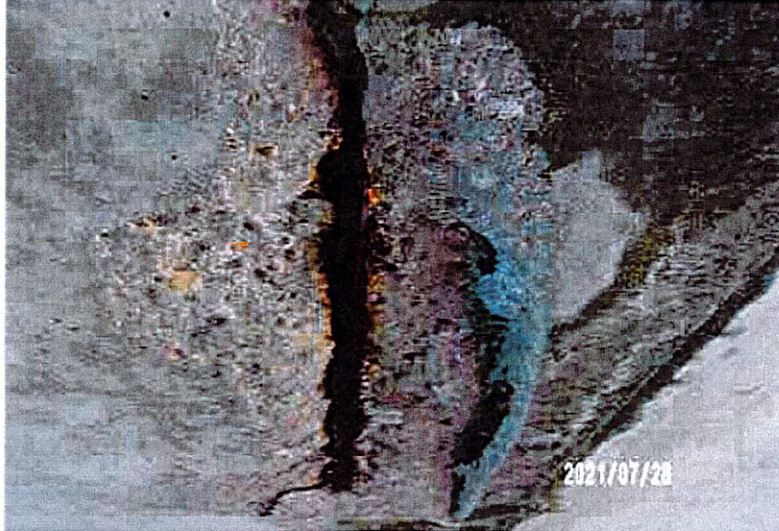
PHOTO 23

DESCRIPTION: Span 3, panel 2 underside, spalling/delamination with exposed corroded rebar.

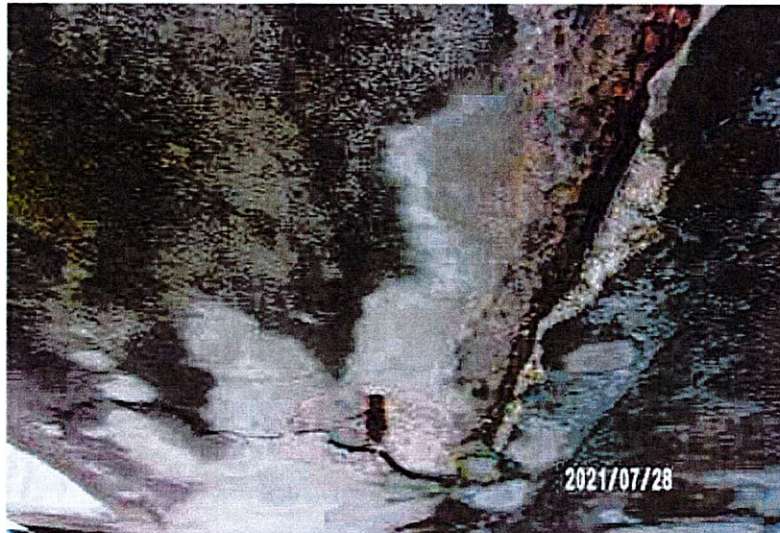
PHOTO 24

DESCRIPTION: Span 5, panel 1 underside, spalling/delamination with exposed corroded rebar.

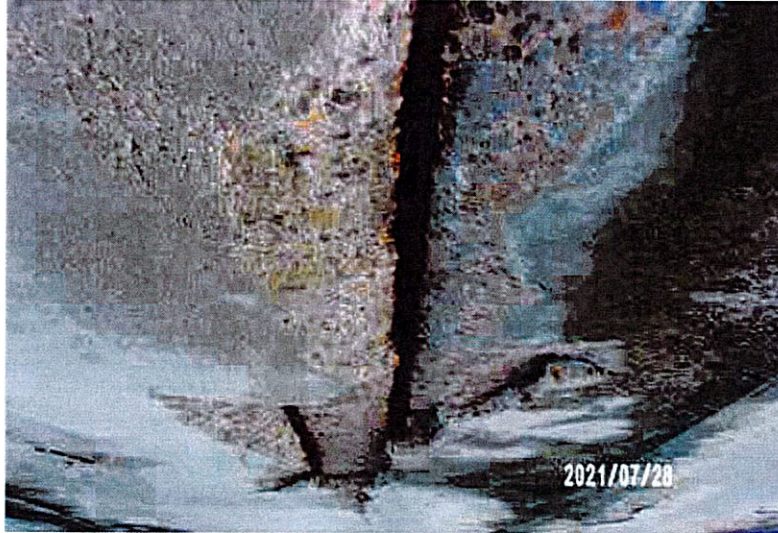
PHOTO 25

DESCRIPTION: Span 5, panel 2 underside, spalling/delamination with exposed corroded rebar.

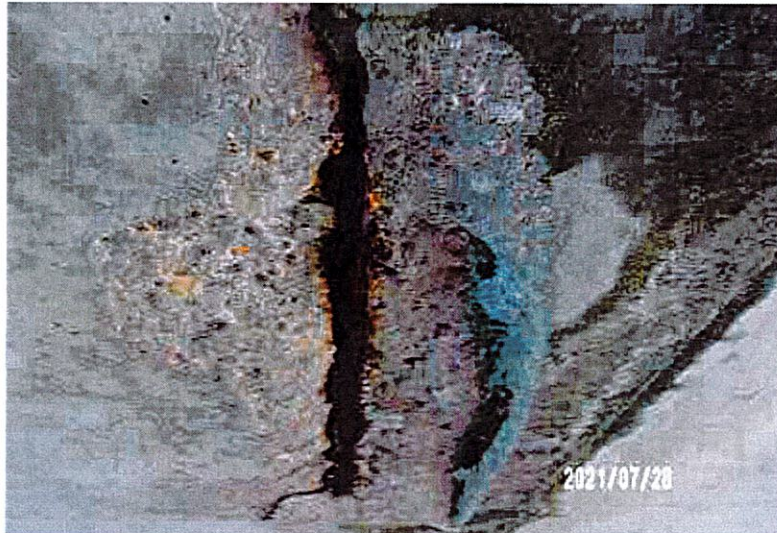
PHOTO 26

DESCRIPTION: Span 5, panel 3 underside, spalling/delamination with exposed corroded rebar.

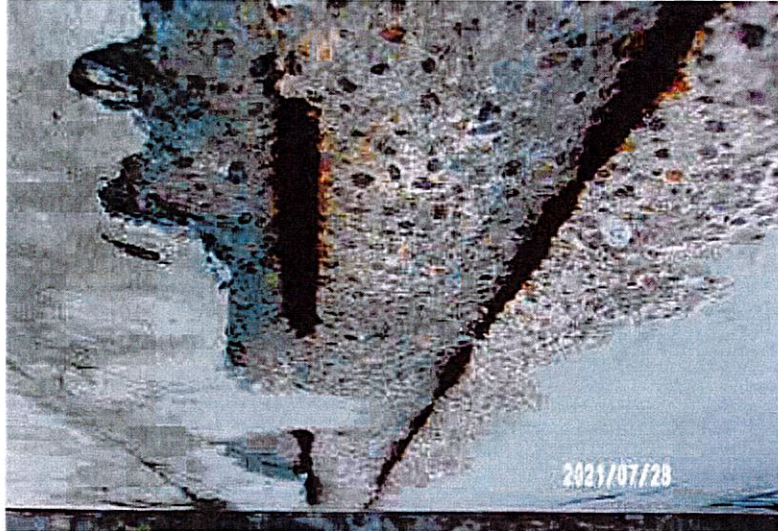
PHOTO 27

DESCRIPTION: Span 6, panel 2 underside, spalling/delamination with exposed corroded rebar.

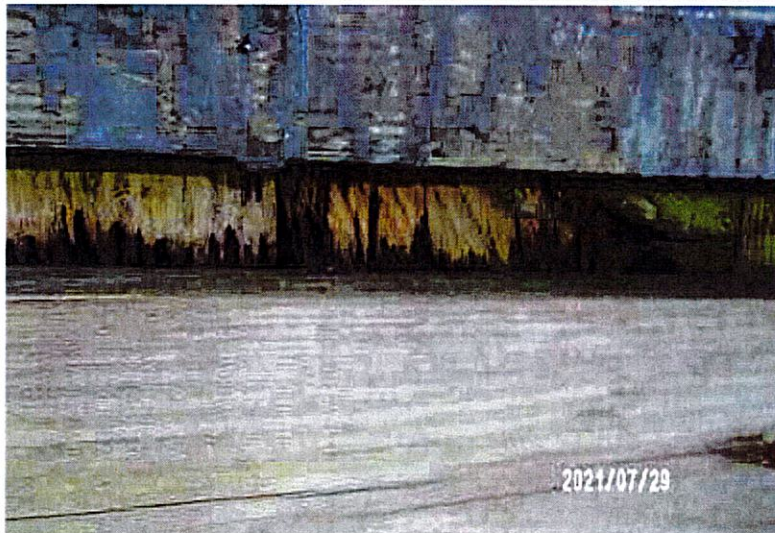
PHOTO 28

DESCRIPTION: Deterioration to inner nearside abutment wall timber. (Typical of both abutments)

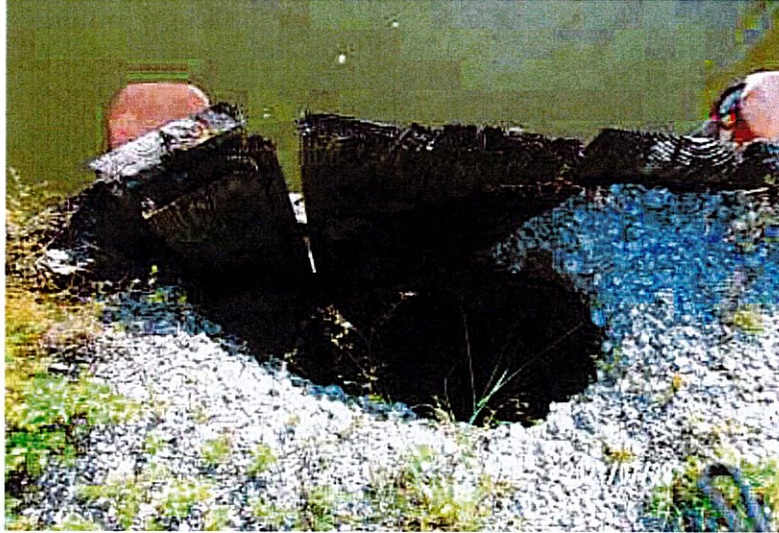
PHOTO 29

DESCRIPTION: Washout between the nearside right wingwall sections.

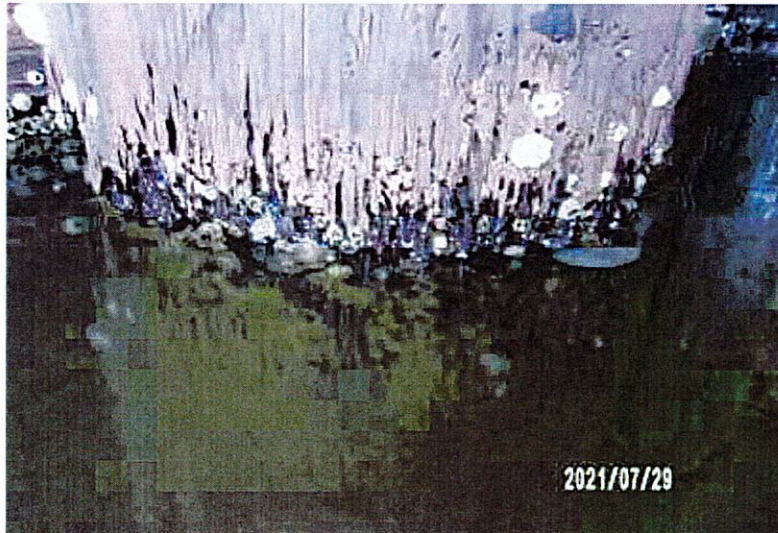
PHOTO 30

DESCRIPTION: Bent 1, pile 4, abrasion/decay.

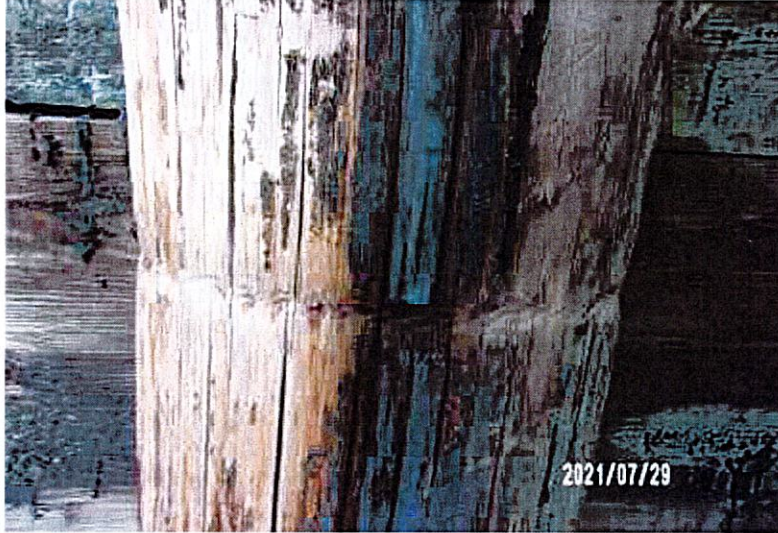
PHOTO 31

DESCRIPTION: Bent 1, pile 5, checking (Typical of most piles).

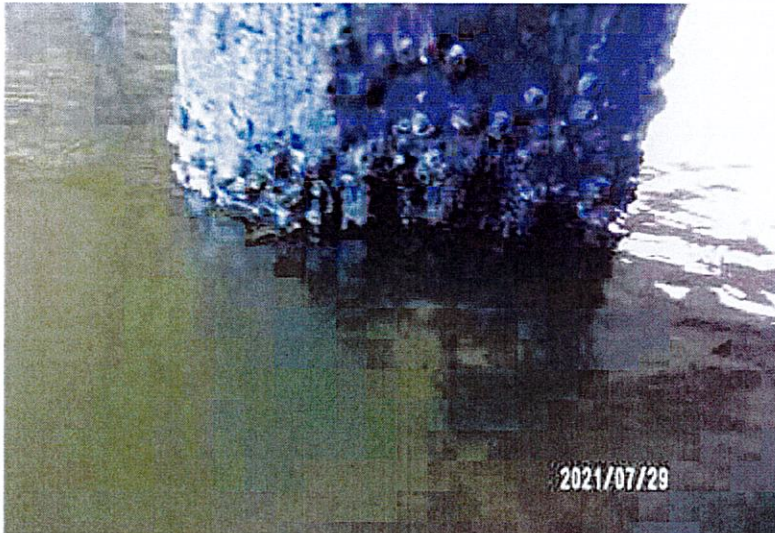
PHOTO 32

DESCRIPTION: Bent 3, pile 2, abrasion/decay.

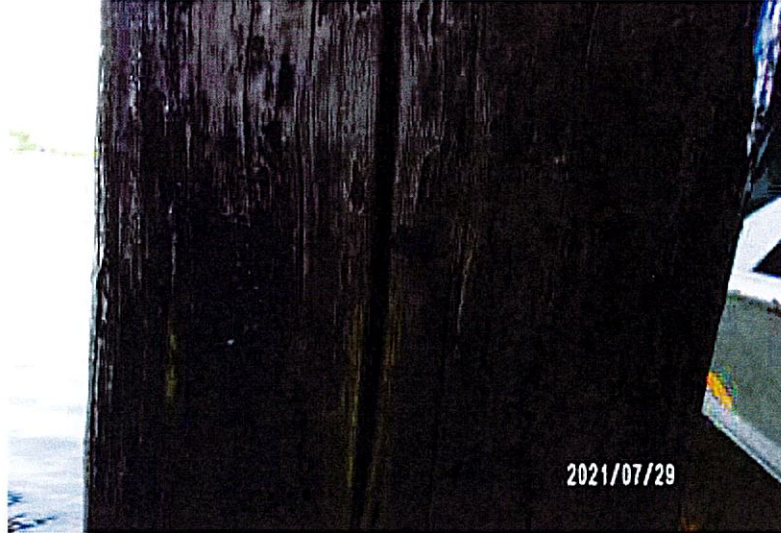
PHOTO 33

DESCRIPTION: Bent 3, pile 4, check.

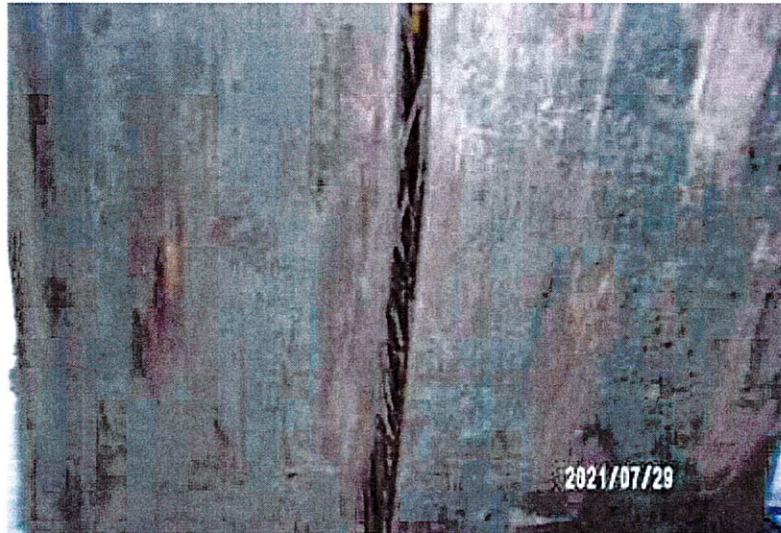
PHOTO 34

DESCRIPTION: Bent 3, pile 4, check.

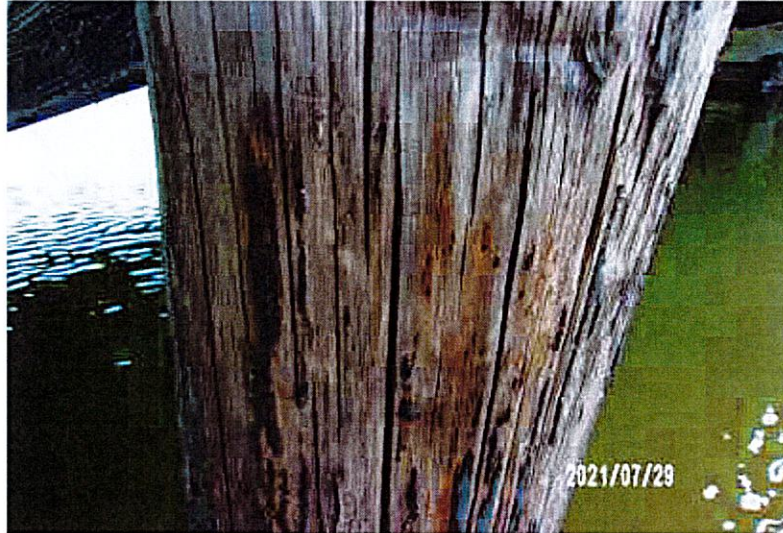
PHOTO 35

DESCRIPTION: Bent 5, pile 5, checked around shell. (Typical of most piles)

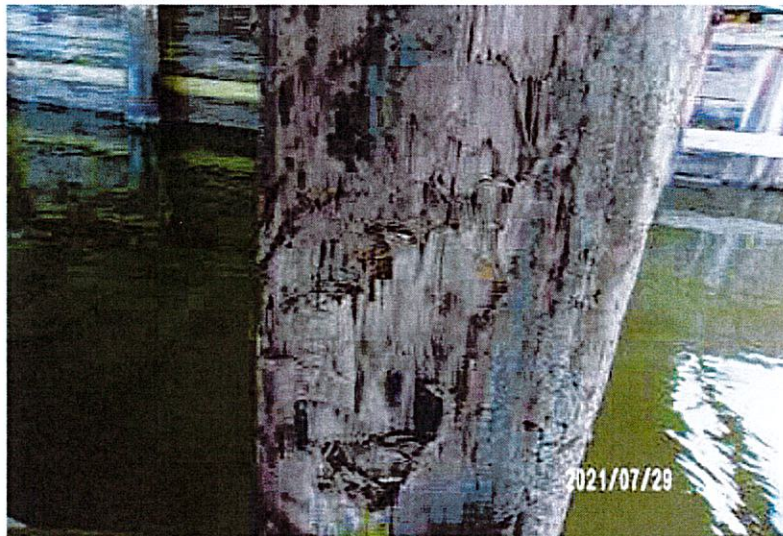
PHOTO 36

DESCRIPTION: Bent 6, pile 4, shell damage.

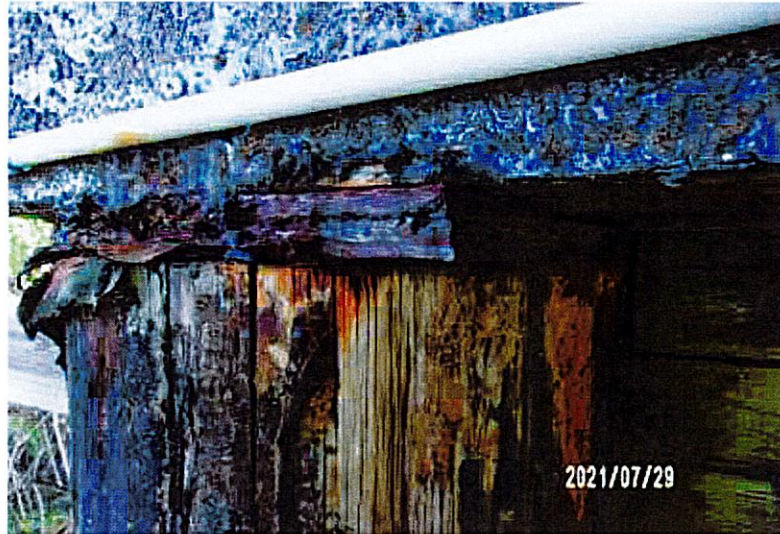
PHOTO 37

DESCRIPTION: Bent 7, pile 1, corroded steel plate shim.

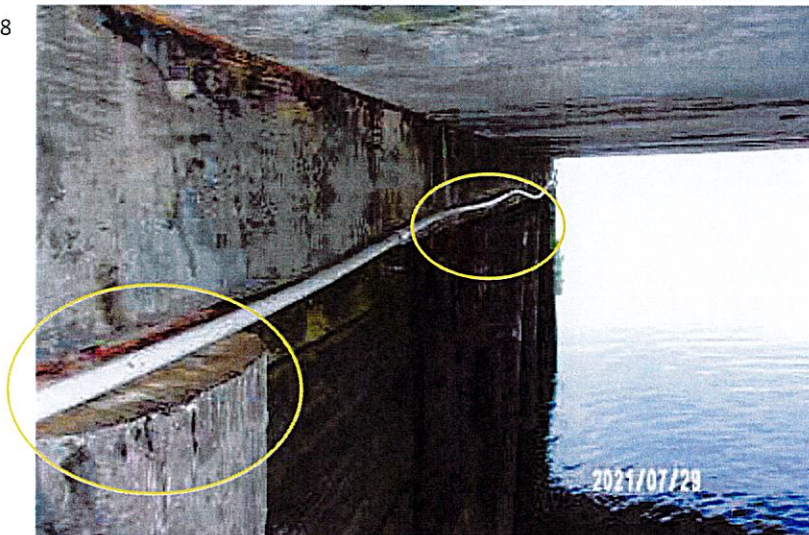
PHOTO 38

DESCRIPTION: Bent 7, piles 2 - 3, not centered under the cap.

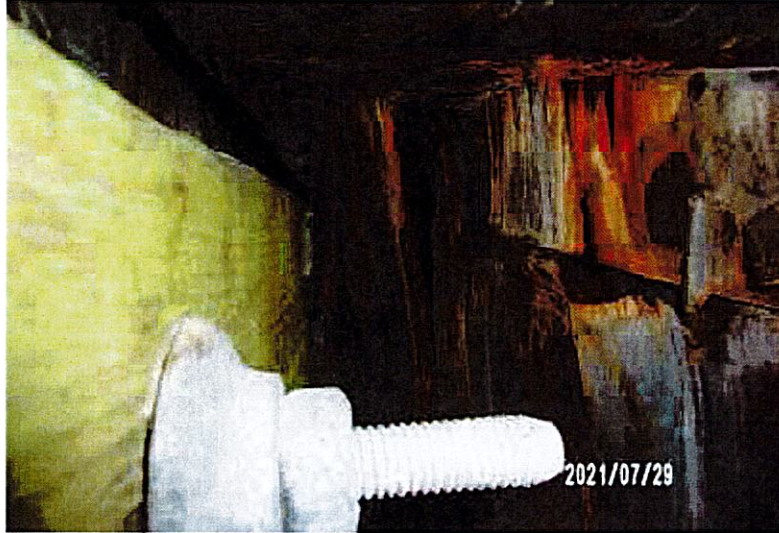
PHOTO 39

DESCRIPTION: Bent 7, pile 3, split.

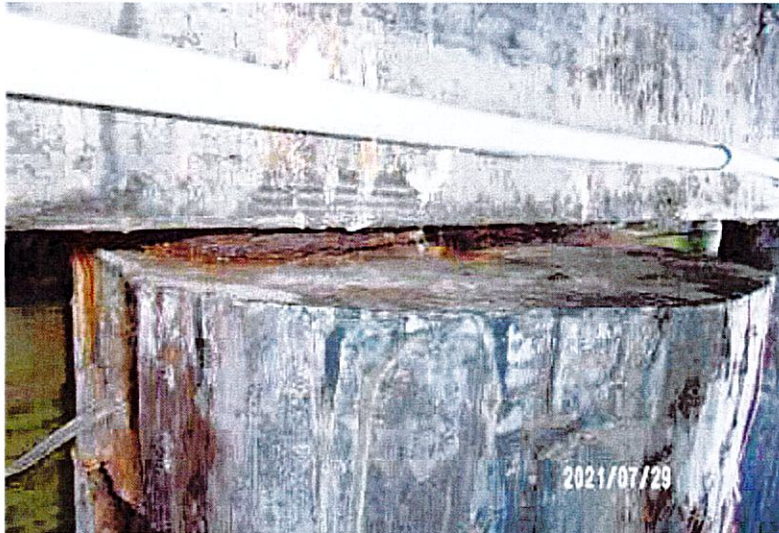
PHOTO 40

DESCRIPTION: Bent 3, pile 7, approximately 25% of pile is load bearing.

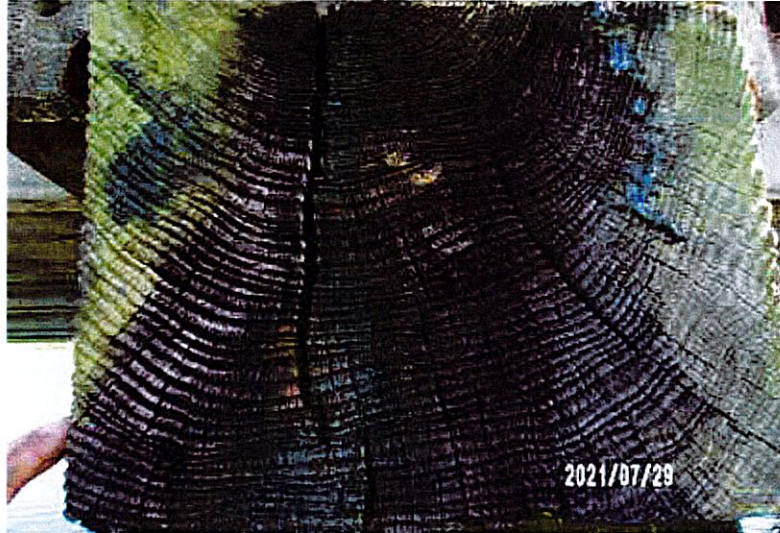
PHOTO 41

DESCRIPTION: Cap 2, right end, split. (Typical of most caps)

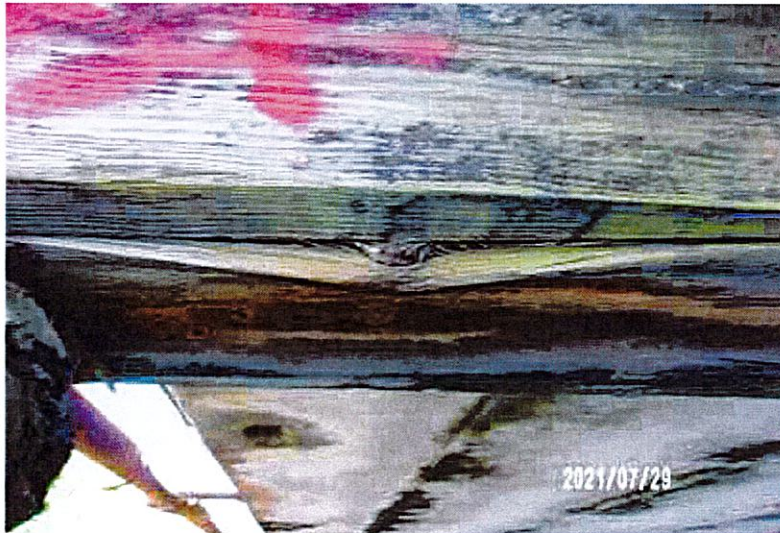
PHOTO 42

DESCRIPTION: Cap 3, split/damage from protruding drift pin.

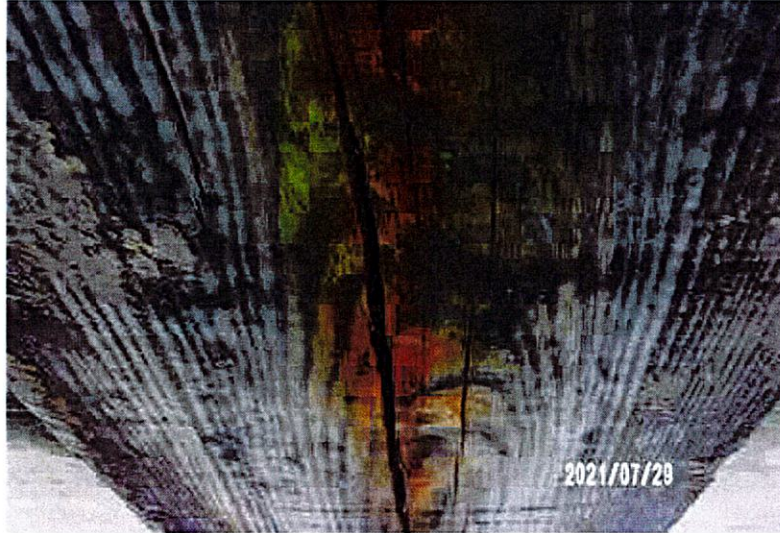
PHOTO 43

DESCRIPTION: Cap 5, split between piles 1 - 2.

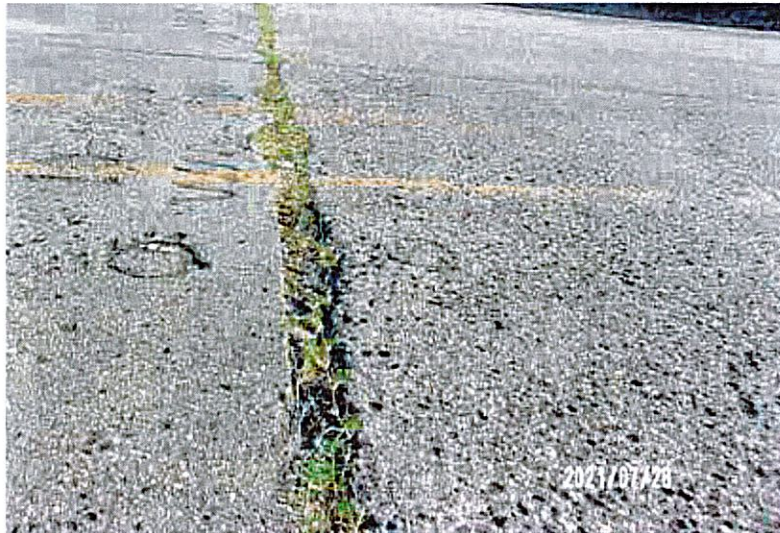
PHOTO 44

DESCRIPTION: Deck joint 2, not sealed/impacted with debris. (Typical of all joints)

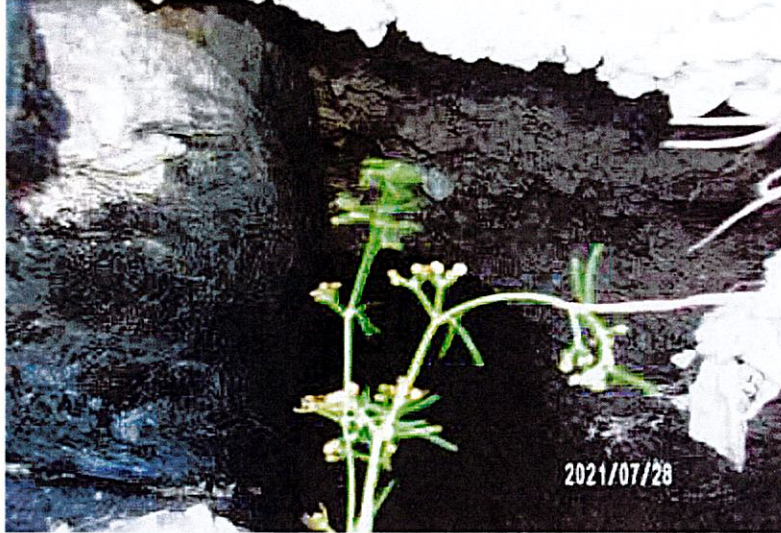
PHOTO 45

DESCRIPTION: Washout/void under nearside approach slab, left lane.
