TERREBONNE PARISH CONSOLIDATED GOVERNMENT

HURRICANE IDA DAMAGE REPAIRS

MAYFIELD BRIDGES #1 & #2

ADDENDUM NO. 2

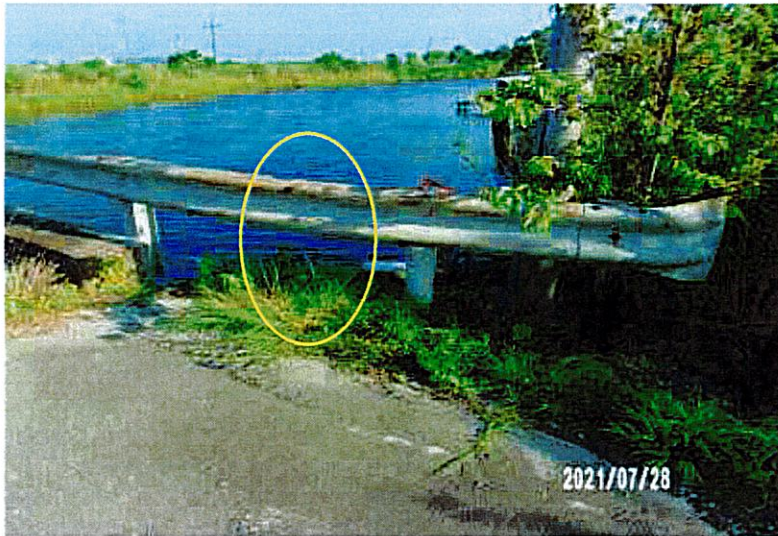
PHOTO 46

DESCRIPTION: Farside left approach rail, missing rail post. (Typical of other approach rails)
