RE: HURRICANE IDA REPAIRS TO

TPCG BAYOU COUNTRY SPORTSPLEX

200 BAYOU COUNTRY ROAD HOUMA, LOUISIANA 70360 ABM PROJECT NO. 201022.00

### ADDENDUM NO. 2

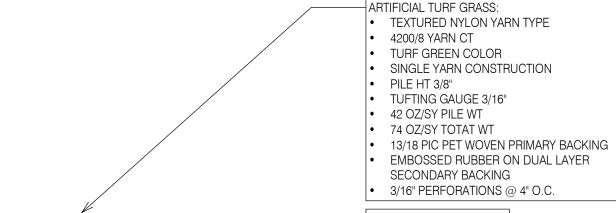
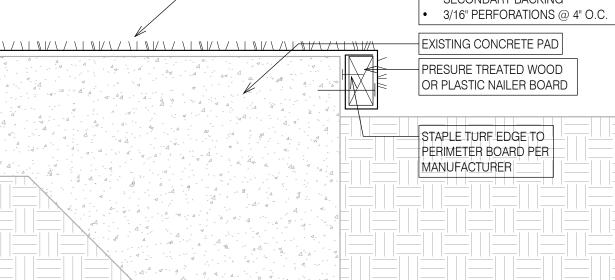
ARTIFICIAL TURF DETAIL

1. WRAP ALL FOUR EDGES AND STAPLE THE TURF TO THE NAILER BOARDS PER MANUFACTURER.

WHAP ALL POOR EDGES AND STAPLE THE TORP TO THE T
 GLUE SEAMS USING SEAM TAPE PER MANUFACTURER.

8. REPLACE MISSING ARTIFICIAL TURF GRASS THROUGHOUT THE ENTIRE BATTING CAGE WITH LIKE KIND. INSTALL USING PRESSURE TREATED WOOD OR PLASTIC LUMBER ATTACHED TO THE SIDES OF THE SLAB. RE: A501 PHOTO #8
