# Bayou Black

## Repetitive Loss Area Analysis

Prepared by  
Terrebonne Parish Department of Planning and Zoning  
985-873-6569  
December 2019

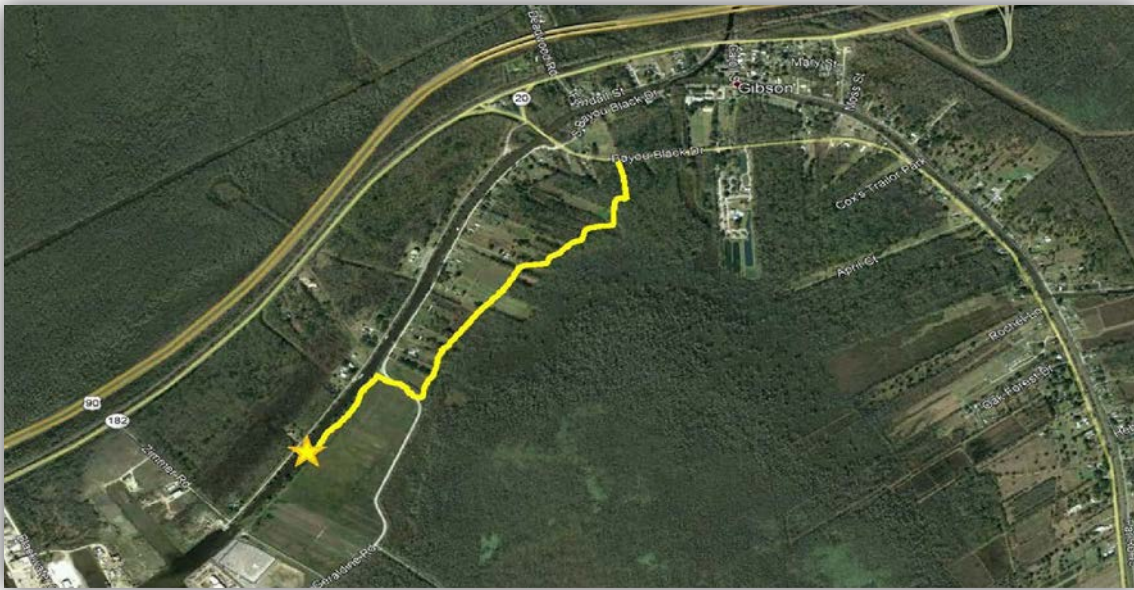
From December 2018 to July 2019, the Chacahoula Basin received over 40 inches of rain. In fact, there were 3 separate rain events that resulted in over 2 inches of rain per hour. Therefore, the Parish implemented temporary mitigation measures to help alleviate flooding in the area. The Parish installed an interim flood protection levee on Geraldine Road to protect the properties on the east side of the bayou.

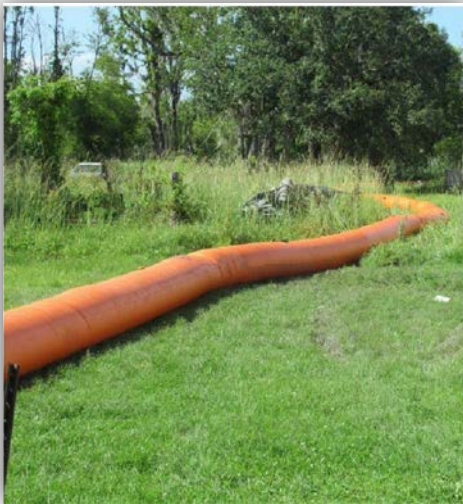
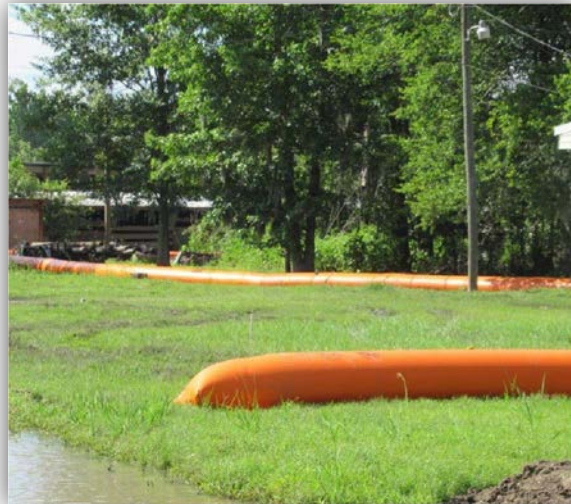
The Parish made use of tiger dams in this instance to protect the non-leveed areas of Gibson, and help prevent the backwater flooding from reaching residents. The photos below show the tiger dams. This measure is effective during times of shallow flooding.

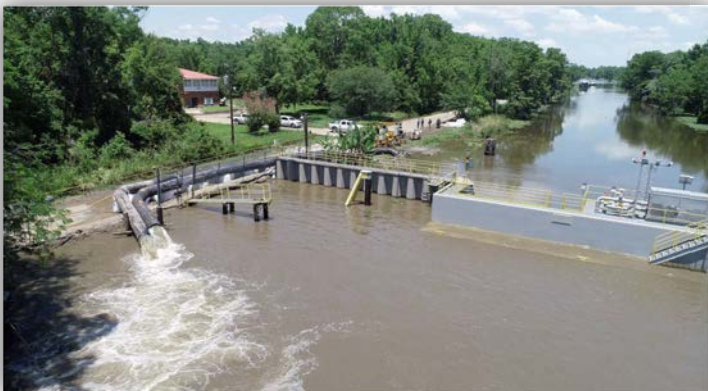
Emergency Pumps at Old Spanish Trail May 2019

The Parish also installed emergency pumps at Old Spanish Trail in Gibson in May 2019, and emergency pumps at Elliot Jones in June 2019. These pumps helped to drain the water out of the area more quickly. The photos below depict the emergency mitigation measures.

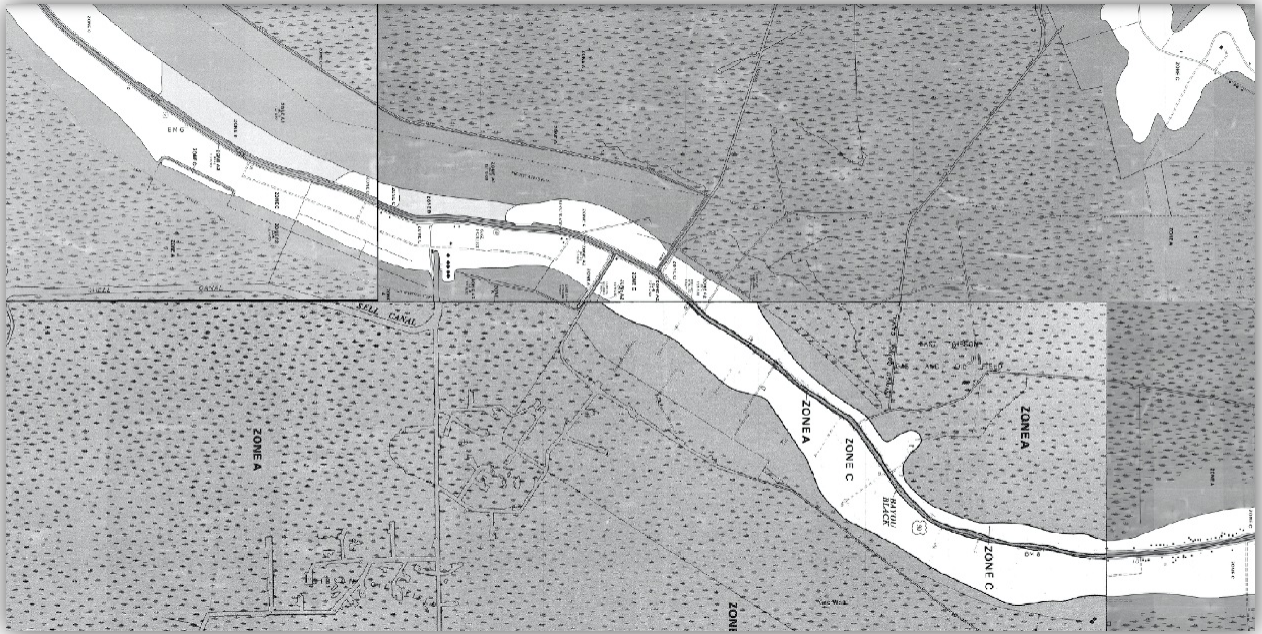
is in the SFHA. As a reminder, the SFHA is the land in the floodplain within Terrebonne Parish subject to a one-percent or greater chance of flooding in any given year.

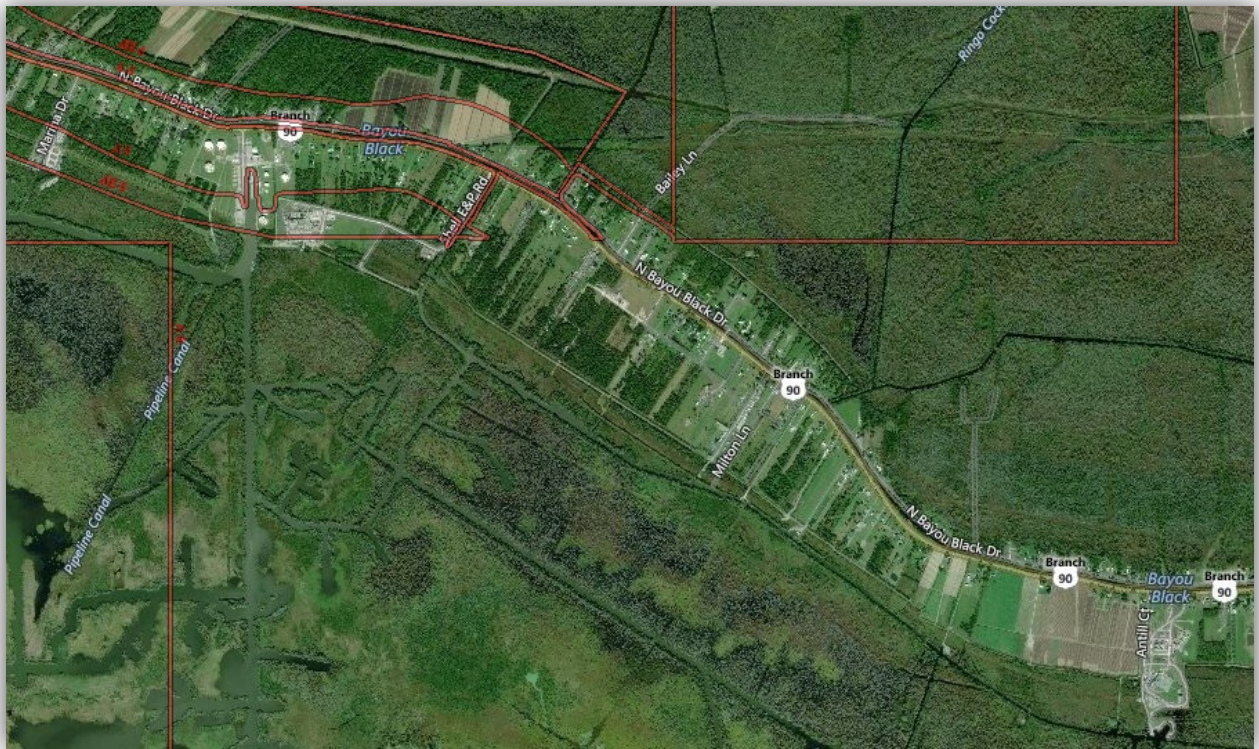
In the Advisory Base Flood Elevation (ABFE) map, which the Parish uses to determine the height of new buildings built in the floodplain, Study Area 1 is not in the SFHA next to the bayou until Shell E&P Road, when the flood zone changes to the SFHA, and the base flood elevation becomes 4 or 5 feet. The base flood elevation is the predicted height of a flood with a one-percent chance of being equaled or exceeded in any given year.

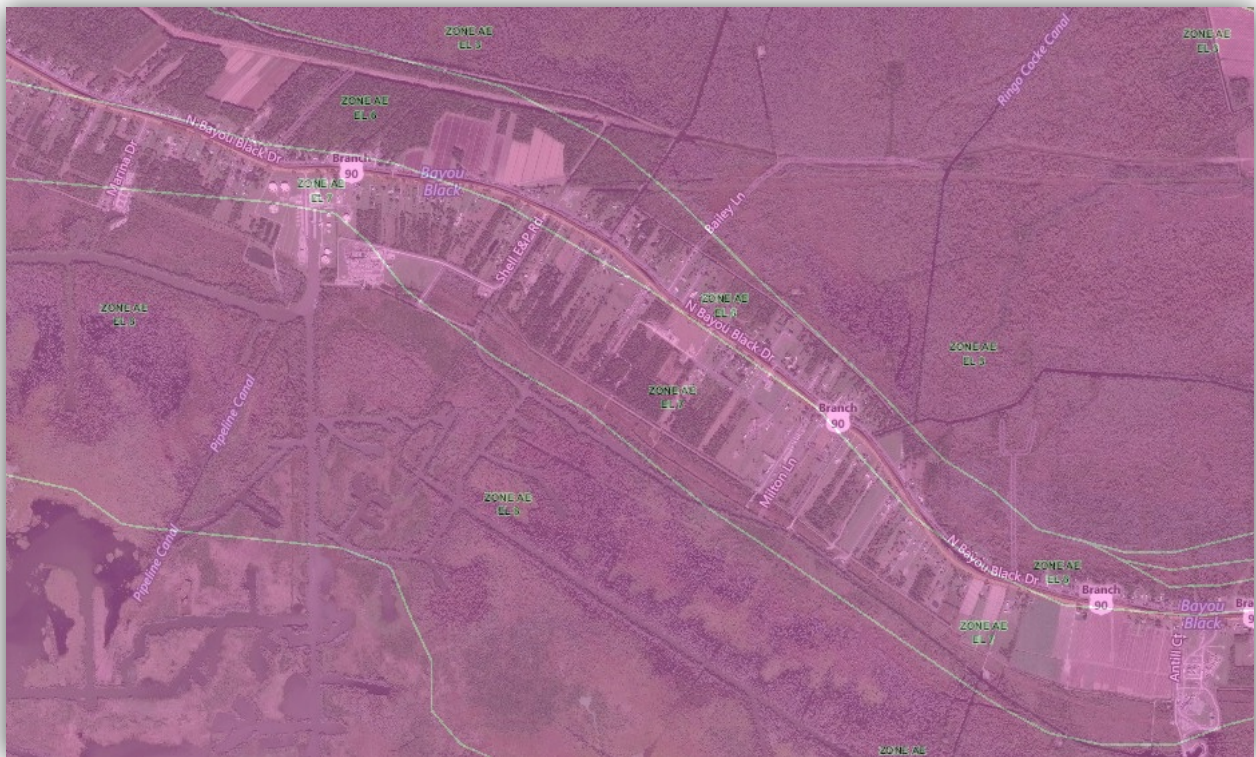
In the preliminary DFIRMs, which the Parish has not adopted, the entire study area is in the SFHA, with base flood elevations ranging from 3 to 6 feet on the east side of the bayou, and 7 to 8 feet on the west side of the bayou.

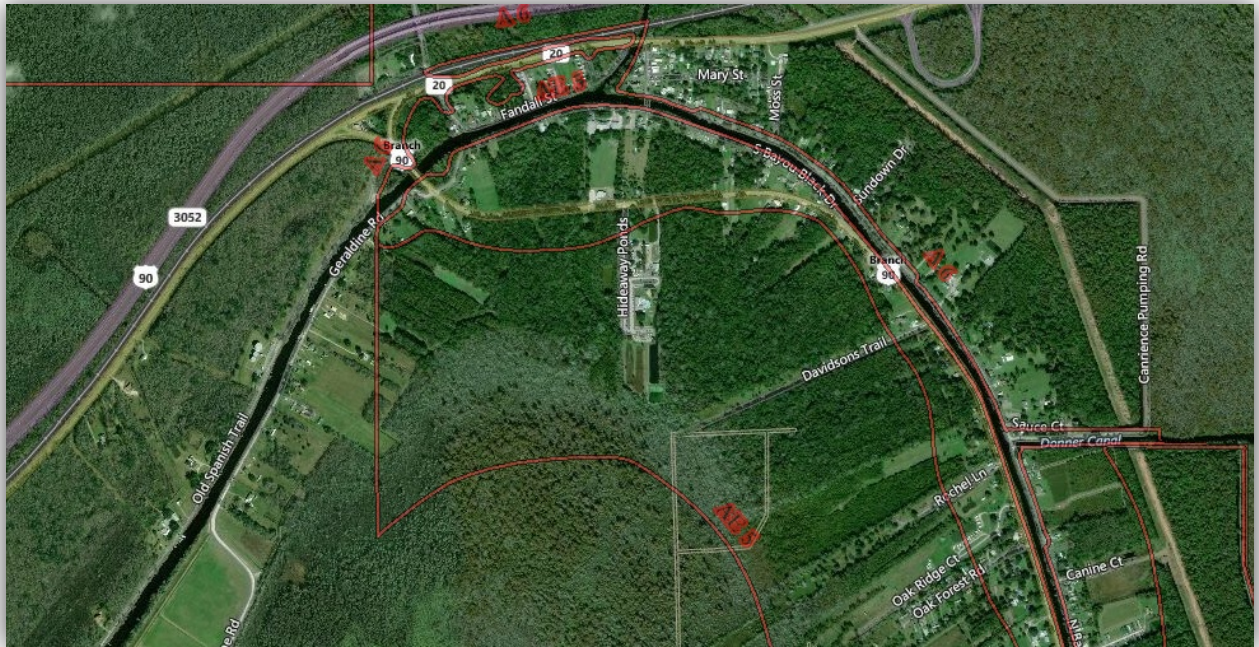
The ABFE map labels both the east and west side of the bayou with base flood elevations ranging from 5 to 6 feet.

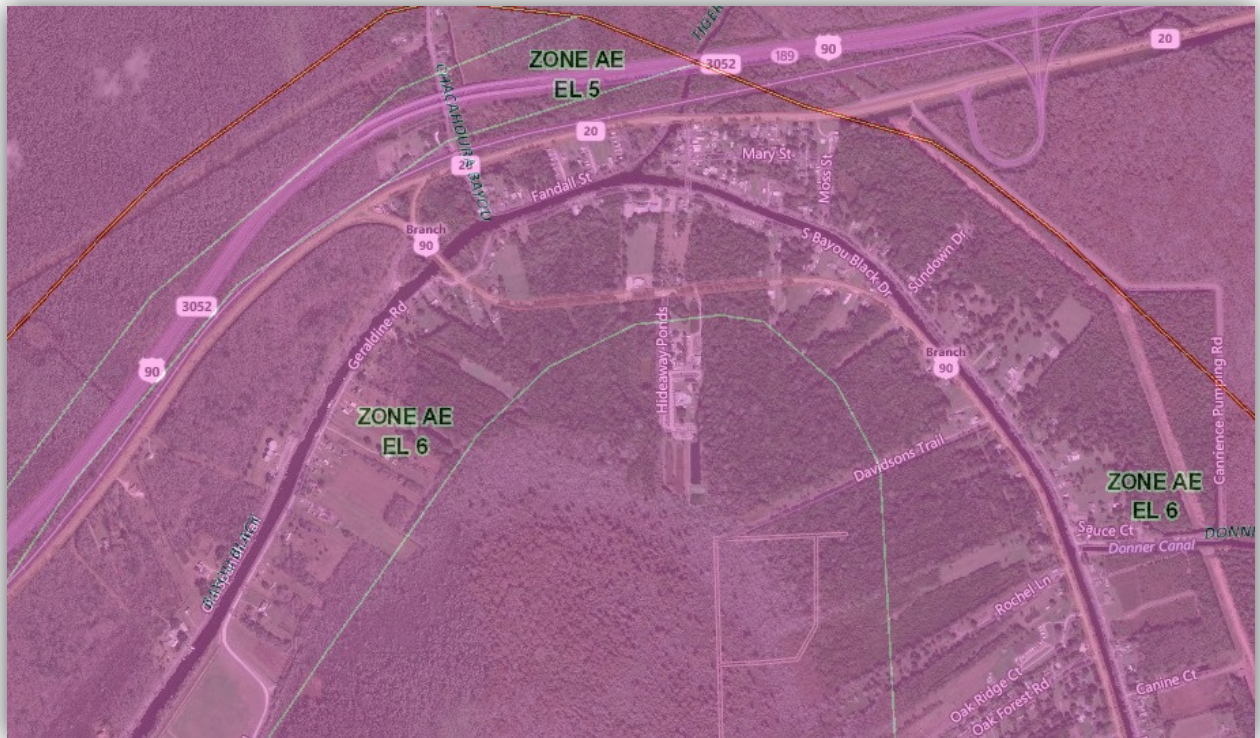
The preliminary DFIRMs also identify base flood elevations ranging from 5 to 6 feet in Study Area 2.

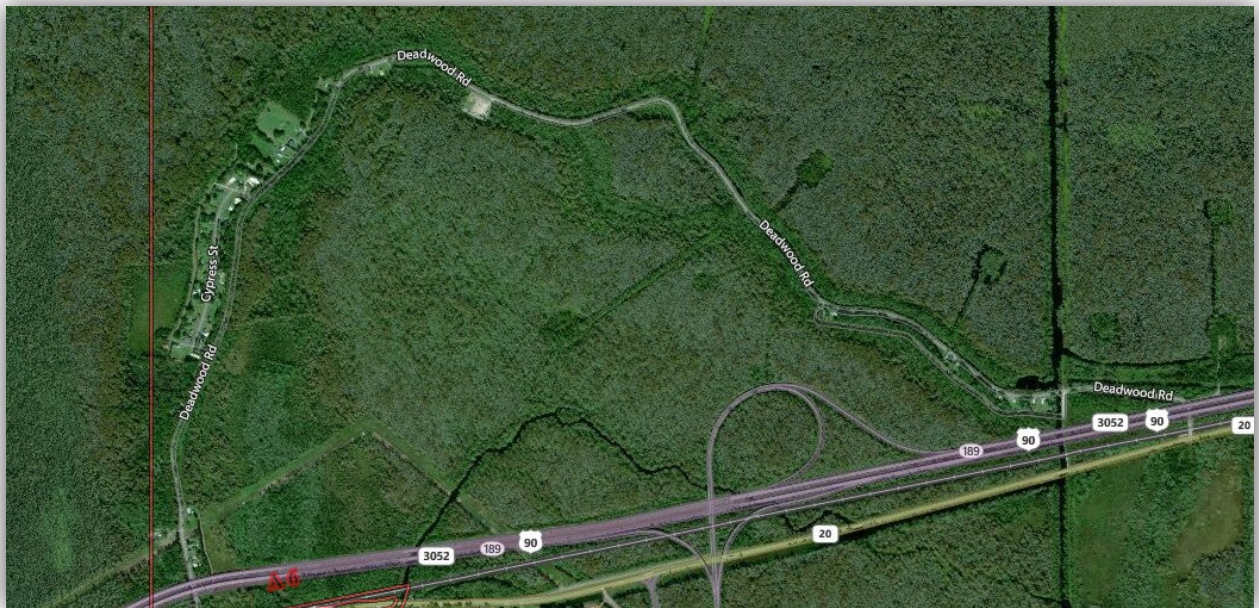
The ABFE map keeps the area in Zone A, and identifies the base flood elevation as 6 feet.

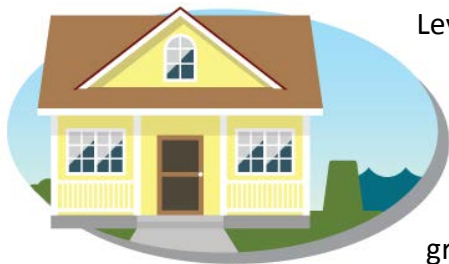
### LEVEE and FLOODWALL PROTECTION

Levees, in conjunction with pump stations, can help with the shallow backwater flooding that can occur in the area. All of the structures in each study area could benefit from this protection. Due to the low and level ground in each study area, forced drainage improvements will be more effective than gravity drainage. When the three planned pump stations and the Geraldine Road levee are complete, the area will be better protected from backwater flooding and rainfall events, and drain more efficiently. The pumps have the potential to be hooked

up to generators and running as of April 2020, but are scheduled to be completed in August 2020. The levee is expected to be completed in August or September of 2020. Once drained, the Shell Oil land will function to retain the water.

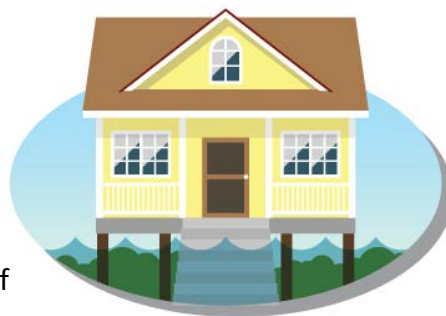
### ELEVATION

The house elevation should be based upon the base flood elevation (BFE) in each study area – 6 to 7 feet in Study Area 1, between 4 and 8 feet in Study Area 2, and from 0 to 4 feet in Study Area 3. It is also becoming more common to use freeboard, or an additional elevated height, such as 1 to 2 feet, to protect structures from flooding. Adding freeboard could help protect homes that are in areas with a low or no BFE, such as in Study Area 3, but still experience shallow flooding from rainfall and poor drainage events. Therefore, the individual recommendations for each structure include elevation for the properties that are below the

BFE to above the BFE plus one foot. The permit office can provide information about base flood elevations for individual properties – please call 985-873-6567.

Many homes in the area are slab on grade, or only elevated a few feet above the ground. In addition, there are some homes that are lower than the street. This can result in shallow flooding of yards during rainfall and flood events, and could even flood homes in a poor drainage situation. Therefore, elevating the structures could help protect homes from the water. A majority of the homes are already on piers, so elevation can be completed more easily compared to houses on slabs.

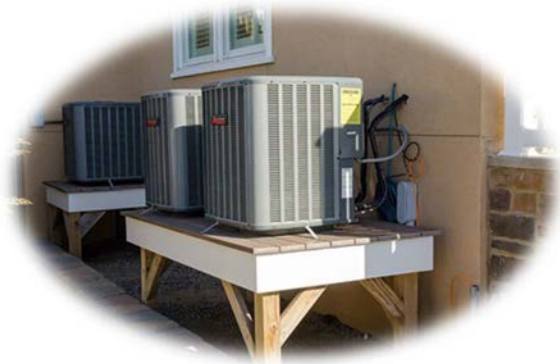
Some homes in the study areas have elevated utilities to prevent flood damage. This analysis recommends that all residents in the areas consider raising their utilities to at least the BFE.

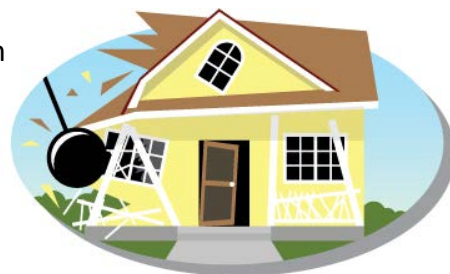
## **DEMOLITION and RECONSTRUCTION**

In some cases, if the structure is in disrepair or the foundation is in poor condition, it may be more effective to demolish and reconstruct the house to a higher elevation. Again, this elevation should be based on the BFE, and could include freeboard to better protect the structure from flooding. FEMA provides funding for demolition and reconstruction as well.

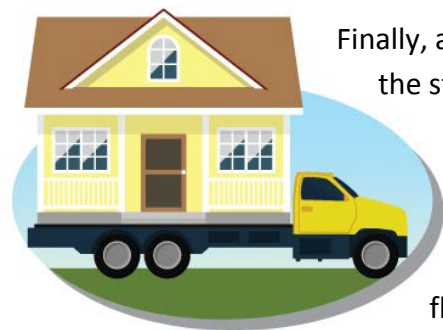
## **RELOCATION**

Finally, acquisition and relocation may be an option for some structures in the study areas. FEMA provides funding for acquisition and relocation, and it could be necessary for homes that are located on the lowest part of a lot, or too close to body of water. While the high land in the area is the land closest to the bayou, there are homes located near canals or low open areas that experience backwater flooding. In addition, there are some unoccupied and abandoned properties that could be acquired for stormwater management purposes.
